DUAL CAB CENTRAL LOCKING CANOPY

Ascent Canopy AC19C – Toyota Tacoma (2024+ Vehicle Production Onwards)

FITTING KIT: 6178410

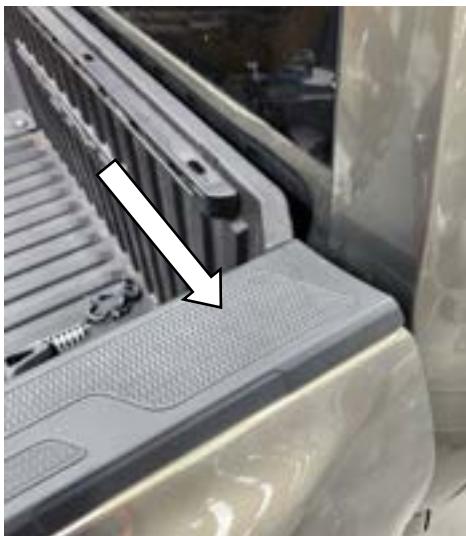
2.0) To allow the canopy water seal to the vehicle's tub, the embossed pattern on the plastic bed caps in the front tub corners near the cabin, needs to be sanded down to be smooth.

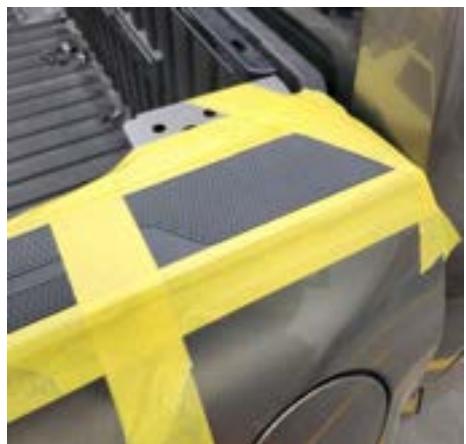
Place masking tape as shown against the external edges of the embossed pattern.

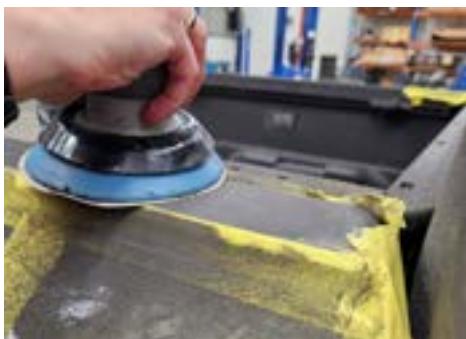
Sand the pattern down until smooth using 80 grit followed by 180 grit sand paper to finer finish.

Take Care not to overheat the plastic during sanding to cause distortion of the plastic bed rail caps.

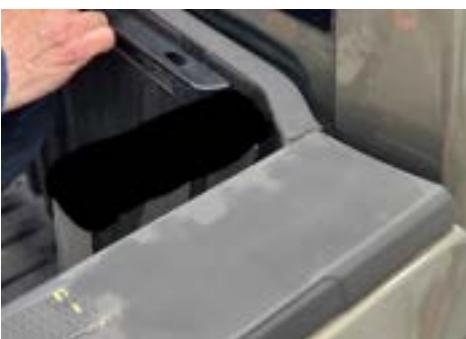
After sanding, the finish should be smooth and neat.

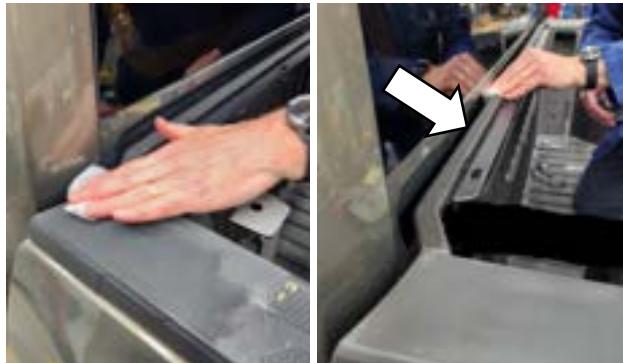
2.1) Using an alcohol wipe (6602018), clean the areas of the bed caps where they were sanded and clean along the upper face of the front of the tub's wall.

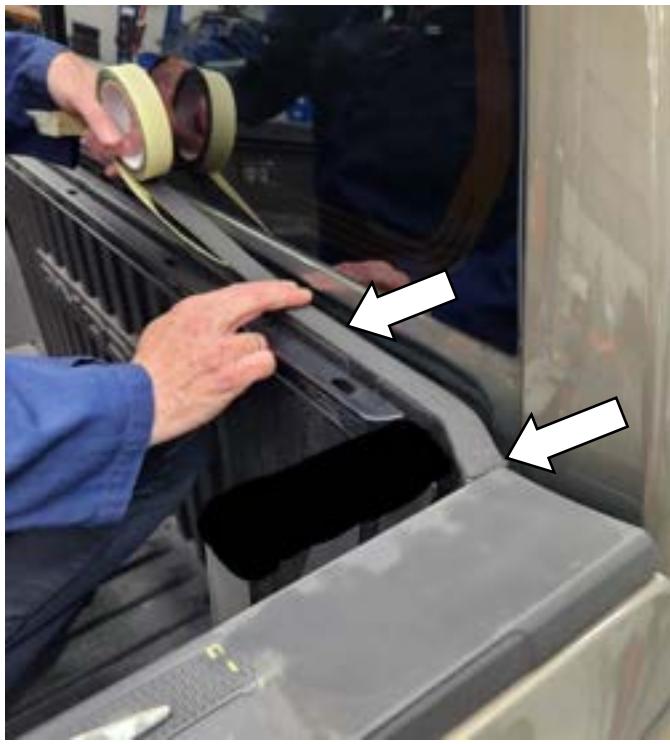
2.3) Apply foam tape (668PB018) on the front tub wall's upper face aligning the start to press up against the inner tub side walls.

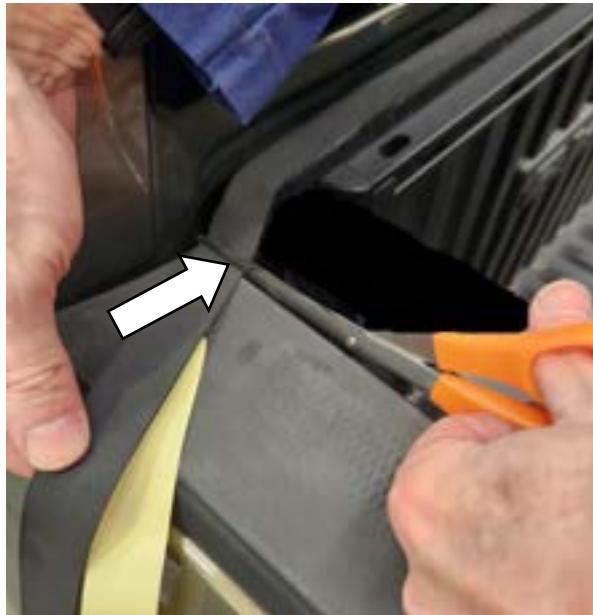
2.4) Apply to the other side and trim this to length, to press up to the inner tub's side rail wall.

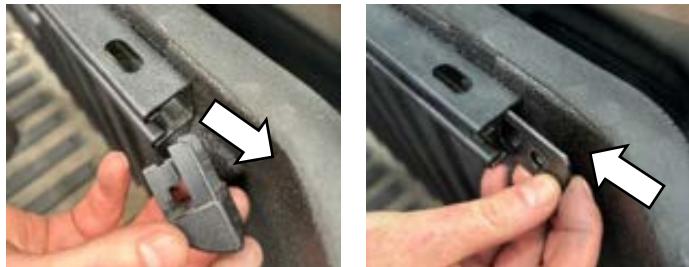
2.5) Remove the end caps from the front CMS Rail on the front wall of the tub.

2.6) Insert M8 nut plates (667AQ010) into each end of the rail with the nut side of the brackets against the tub wall's face.

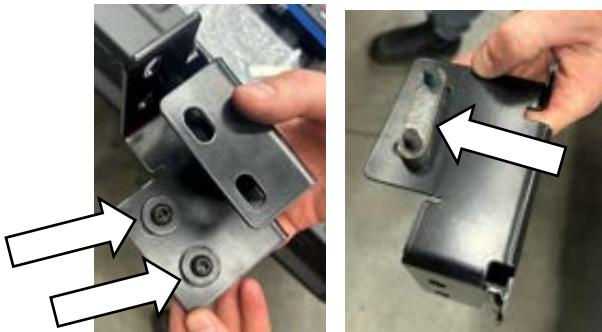
2.13) On the side of the tub remove the CMS side rail end cap. Insert M8 nut plate (667AQ010) into the front end of the rail with the nut side of the brackets against the tub wall's face. **Repeat on opposite side the vehicle.**

2.14) Assemble the front tub corner mounting brackets (667PD024R/L) with:

- Four Torx head screws M8 x 25 (6151625)
- Four flat washers M8 x 25.4 x 3mm (4581303)
- A bumpon (665076) on each bracket tab.

2.15) On the back of the screws on each bracket, add the spacer plate (6253456)

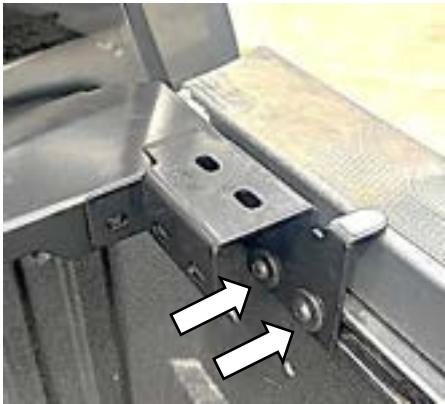
2.16) Place the respective front tub corner mounting brackets (667PD024R/L) up against the upper front header rail (668PD198) and thread the bolts into the nut plate in the side CMS rail to a **Loose fit**.

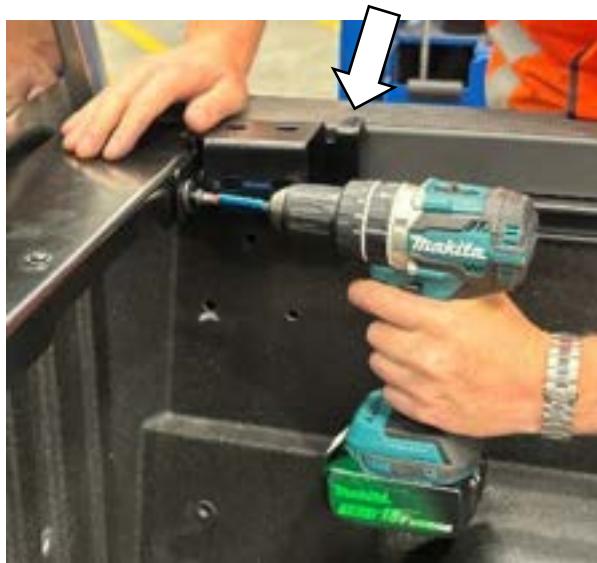
2.18) Once assembled, **tighten the two screws to the front header rail to 20Nm** whilst ensuring the tab on the corner mount brackets with the bumpon is pushed down to engage the top of the tub. **Then tighten the side screws on the bracket to the side CMS mount rail of the tub to 20Nm.** Repeat on both sides of the vehicle.

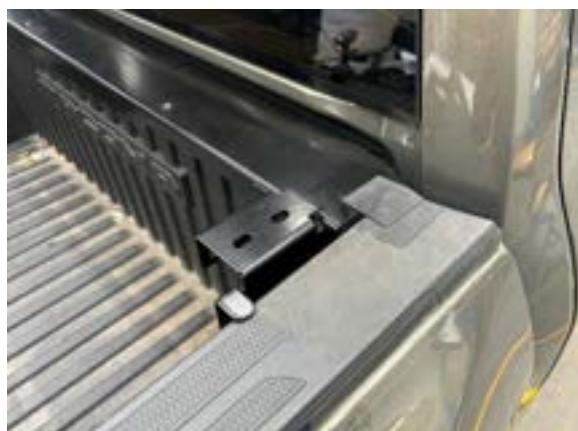
!! IMPORTANT !!
POSITION THE SEAL BRIDGE
EXACTLY AS SHOWN OR
FRONT CORNER WATER
LEAKS COULD OCCUR

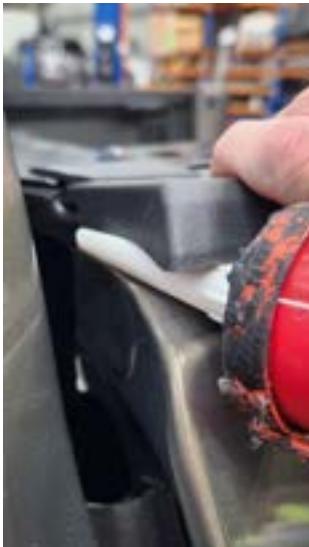
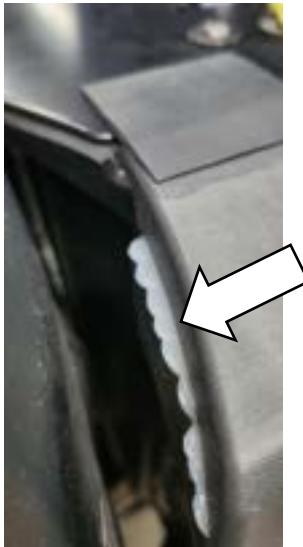
2.24) Lift the front corners of the plastic bed caps on both sides of the tub and apply neutral cure non-acetic silicone under them to create a water seal.

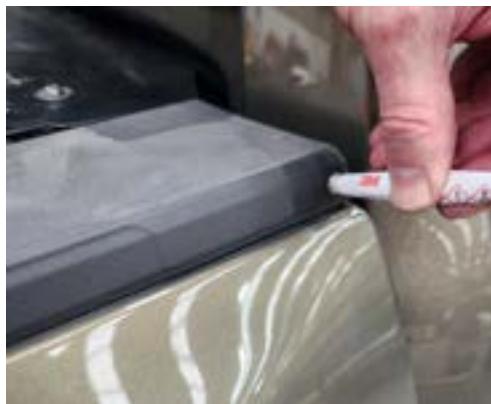
2.29) On the outside on both sides of the tub, clean along the outer faces of the bed rail caps with an alcohol wipe (6602018) and then prime them using the primer stick (665044) along the angled face of the plastic part for the length of the tub on both sides.

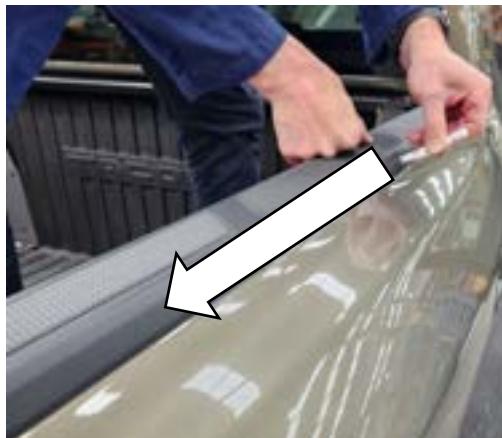
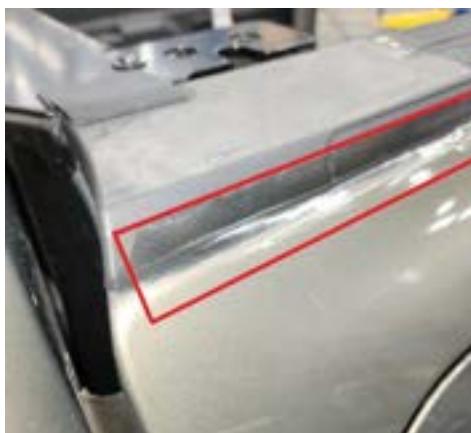
2.30) Apply one roll of clear tape (665037) per side of the vehicle, at the junction between the bed cap and the painted tub sheet metal. Align the centre of the tape to the junction between them.

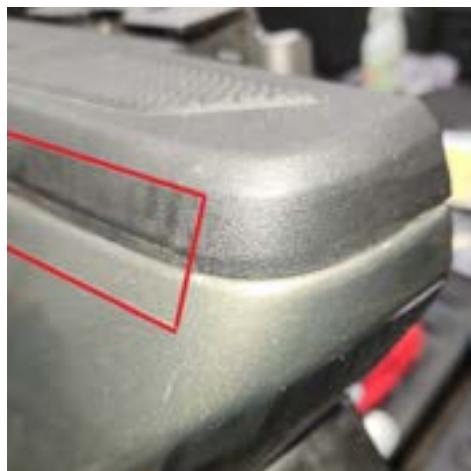
Run the roll out to finish near the rear corners of the tub.

Apply pressure along the tape and into the seam to gain good adhesion into the joint.

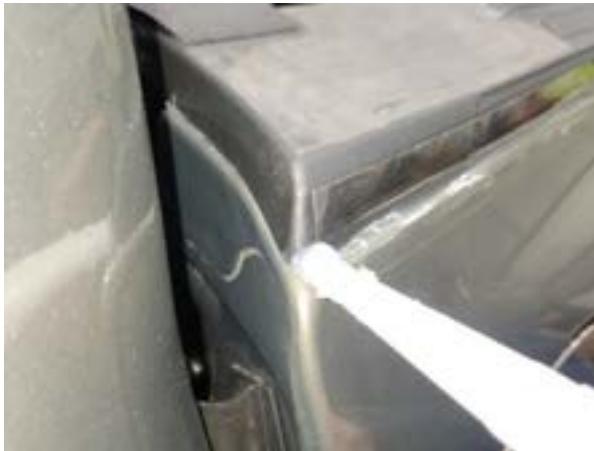
2.31) At the front tub corners, apply silicon along the leading vertical edge of the clear tape to aid in sealing and clean off the excess.

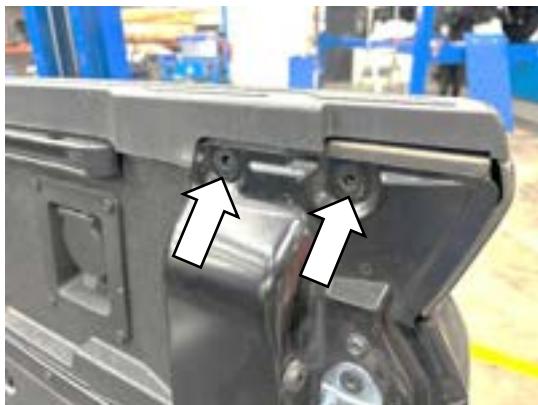
3.0) Remove the two OE upper rear M6 bolts on both sides of the tub.

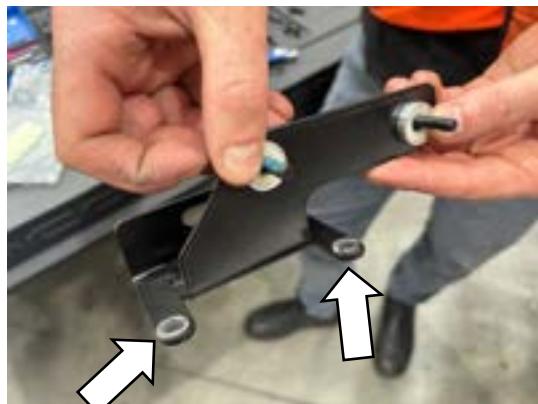
3.1) Add two bumpers (665076) to the two underside of the tags on each of the rear tub mount bracket assemblies (667AQ011R&L)

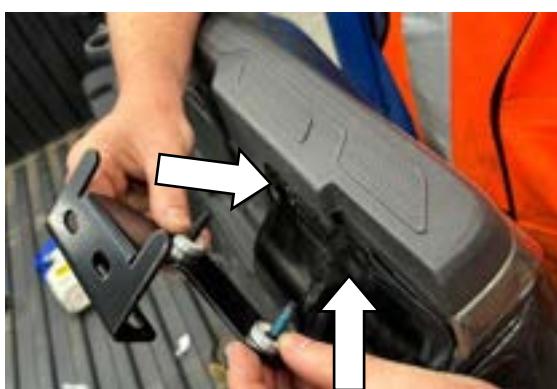
3.2) Fit the assembled rear tub mounting brackets (667AQ011R&L) to the vehicle's tub locating the threads of the already assembled bolts on the brackets into the threaded holes in the rear of the side of the tub.

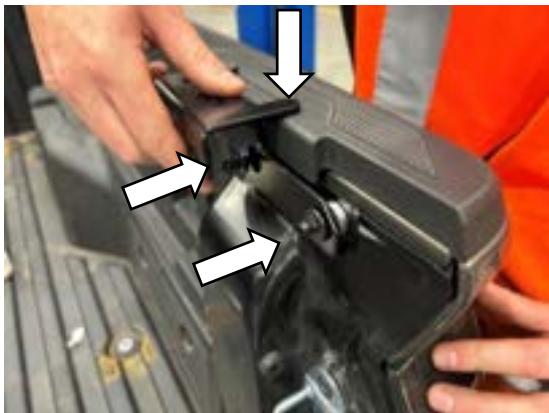
3.3) Whilst pressing down on the brackets so the bumpons are touching the upper surface of the tub, tighten the M6 screws using a T30 Torx driver **to 9Nm.**

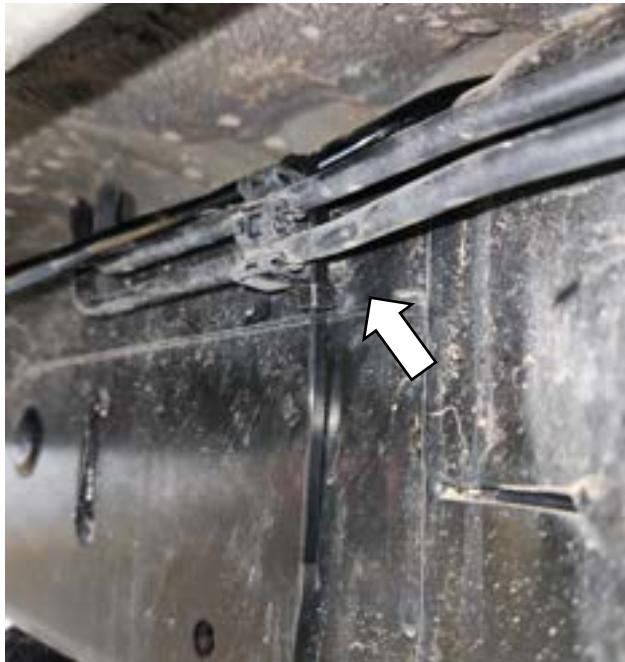
4.6) Route the canopy harness (667PJ005) rearward along the right-hand chassis rail. Cable tie it to the mounting bracket supporting the vehicle's brake lines.

DO NOT Cable tie to the brake lines.

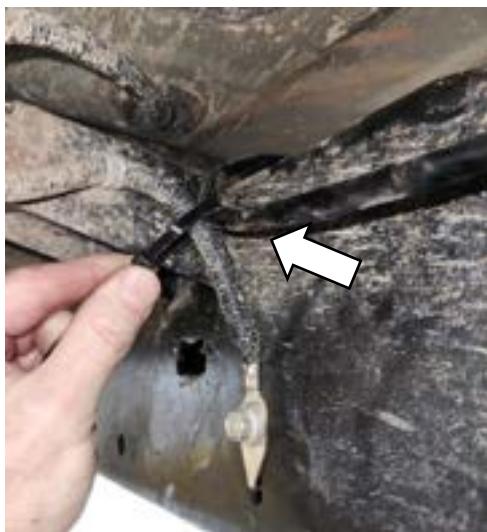
4.7) Running rearward, cable tie the harness to the earth loom on the vehicle.

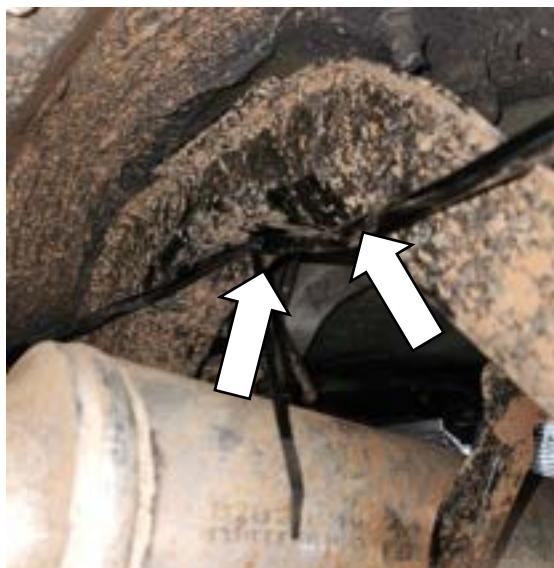
4.8) Cross the harness from right to left of the vehicle above the tail shaft and tie off with two cable ties above the tail shaft to the body structure above it to ensure clearance.

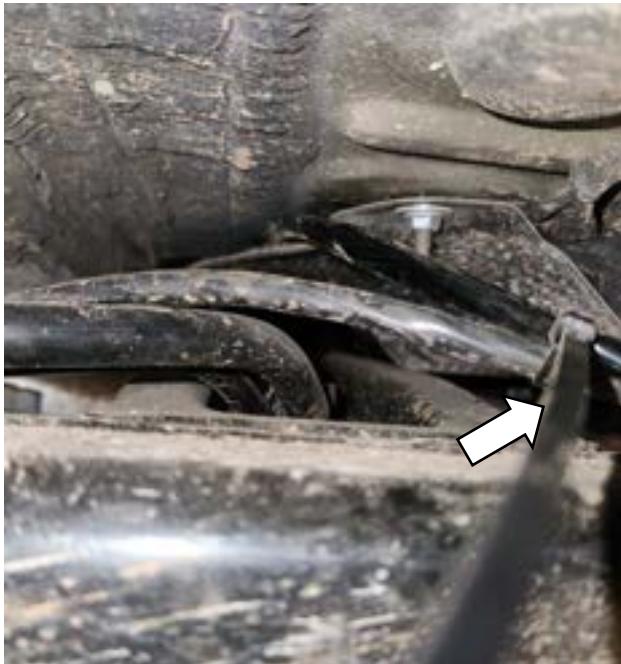
4.9) Run the harness behind the exhaust heat shielding and over to the left-hand chassis rail. Add a cable tie to secure it to the vehicle's loom in this position.

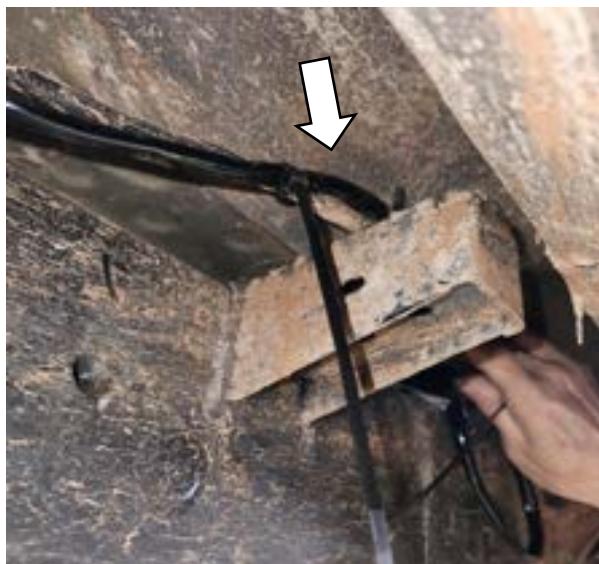
4.10) Cable tie the harness to the vehicle's loom above the body support bracket.

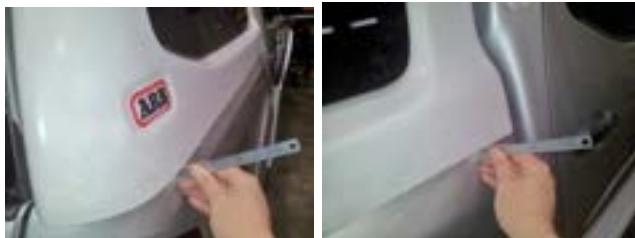
TOP VIEW OF FRONT CORNER OF CANOPY ON VEHICLE:

POSITIONING OF CANOPY ON TUB:

The canopy should be positioned so the lower door edge's sash seal is sealing well and evenly along its length to the tailgate.

Check minimum gap from canopy front pillars and cabin is 20mm minimum at the closest point of the pillar to the vehicle's cabin.

Check the front lower corners of the canopy are aligned to the beginning of the edge radius at the front of the tub.

Measure the trim edges of the canopy at both the front and rear sides, to the vehicle's tub.

This measurement should be even on both sides of the canopy.

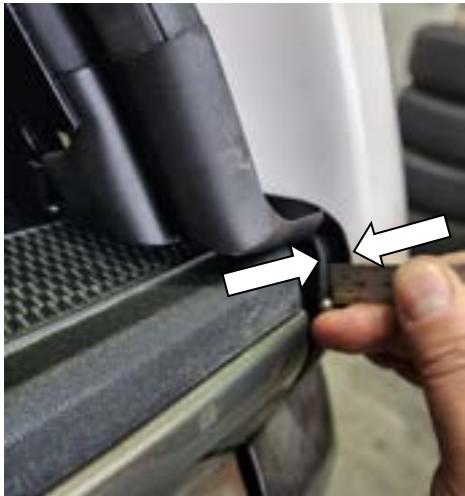
Check the gap of the canopy shell's rear trim edge corners to the tub. It should be even on both sides of the canopy.

!! IMPORTANT !! The gap between the rear pillar corner piece should be 7mm or more and even both sides

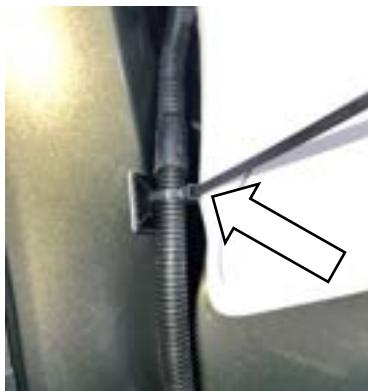
CLEAN AND PLACE CABLE TIE BASE HERE

5.7) Cable tie the (6821293) cable tie base to the canopy loom at the front left-hand outer corner of the canopy, in the location shown (below the lower end of the tube of the rubber grommet) tight enough, to not allow it to fall down the loom and in the orientation shown.

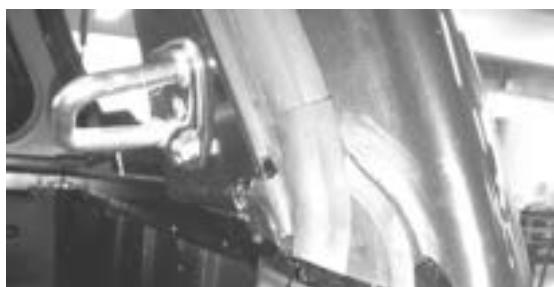
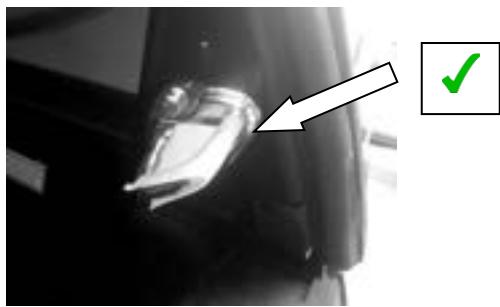
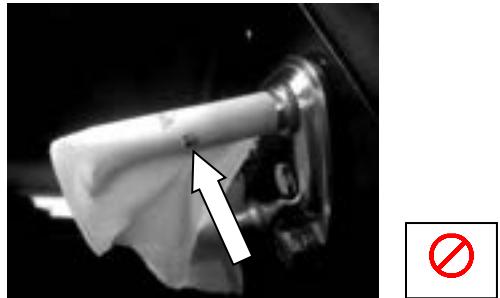
If the latches can be seen to bind on the door frame strikers, it may be necessary to adjust the door frame strikers.

- Place one thickness of masking tape around the striker bar where the latches contact. Open and close the door. If the tape shows signs of wear through on the top side or underneath of the striker bar, it is necessary to adjust the striker away from the side on which the wear is shown. **The aim is only to have wear on the outward face of the striker bar.**

- Undo the M6 screws slightly on the strikers and adjust their position slightly. **Re-torque screws to 9Nm.**

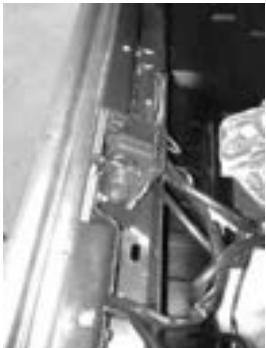
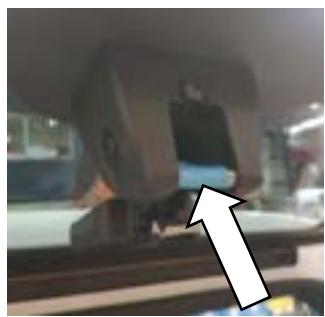
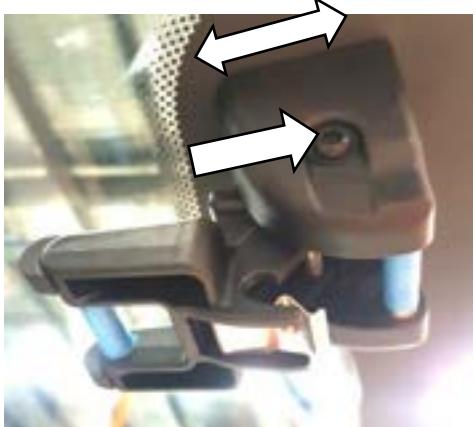
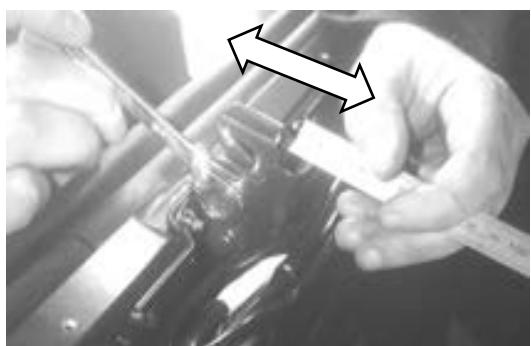
6.4) Operate the push button switch on side lift-up windows. If the windows will not latch properly, and the solenoid can be heard working, the latch can be adjusted in the following steps.

- Remove the rotary latch cover on the window frame.
- Operate the window with a person outside pushing the button and closing the window slowly. Look to see the striker bar on the glass does not scuff the leg on the rotary latch pawl as the window closes. The striker bar should close into the middle of pawl slot on the rotary latch on the frame. Place one thickness of masking tape around the striker bar where the latch contacts. Open and close the window. If the tape shows signs of wear through on the top or underside of the striker bar, it is necessary to adjust the striker away from the side on which the wear is shown. **The aim is only to have wear on the outward side of the striker bar not above or below in closed position.**

- Two M6 Torx screws can be undone with T30 bit and **re-tightened to 7Nm** on the glass mounted striker on either side to move the position of the striker up and down on the glass.

- The rotary latch on the window frame provides window in/out adjustment. Measure the distance between the back of the rotary latch and its mounting bracket and take note of it (9mm). Loosen the bolts through the latch and move the latch out 1mm at a time and **re-tighten to 9Nm** and test the window until it opens and closes and seals satisfactorily.
