FITTING INSTRUCTIONS

DUAL CAB CENTRAL LOCKING CANOPY

Ascent Canopy AC19C – Toyota Tacoma (2024+ Vehicle Production Onwards)

FITTING KIT: 6178410

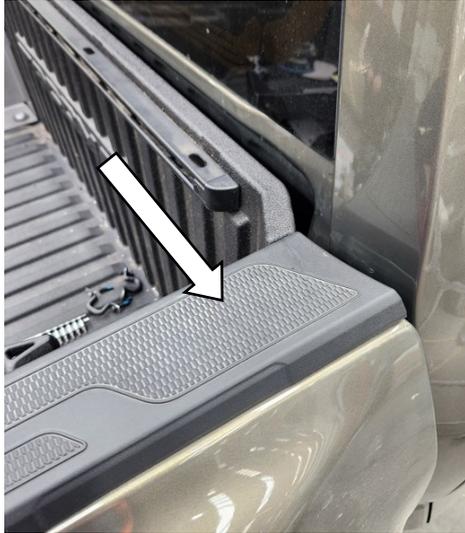
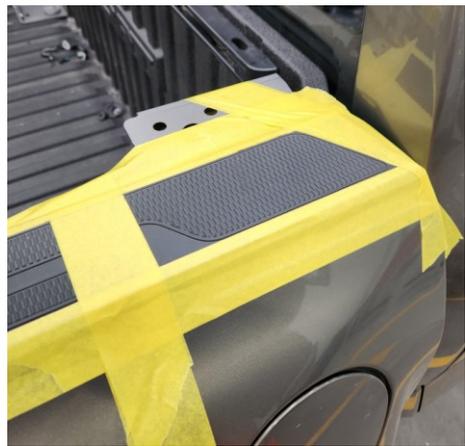
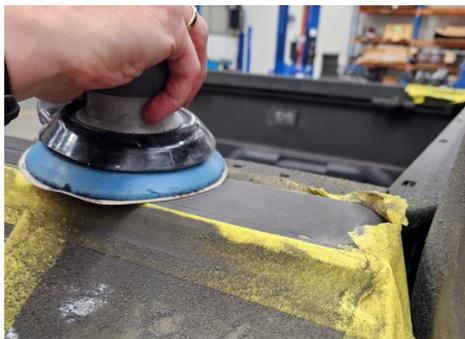
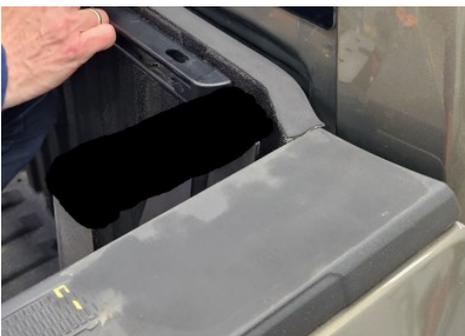
2.0) To allow the canopy water seal to the vehicle's tub, the embossed pattern on the plastic bed caps in the front tub corners near the cabin, needs to be sanded down to be smooth.

Place masking tape as shown against the external edges of the embossed pattern.

Sand the pattern down until smooth using 80 grit followed by 180 grit sand paper to finer finish.

After sanding, the finish should be smooth and neat.

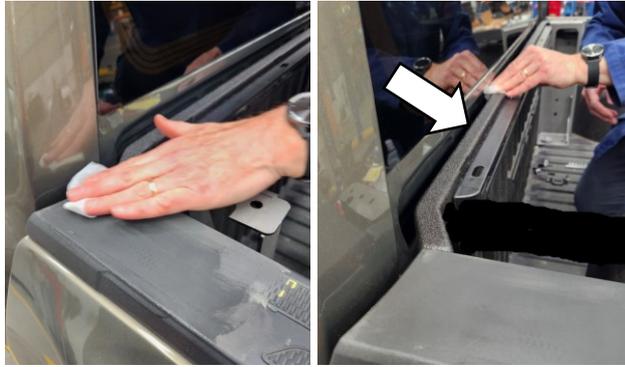
2.1) Using an alcohol wipe (6602018), clean the areas of the bed caps where they were sanded and clean along the upper face of the front of the tub's wall.

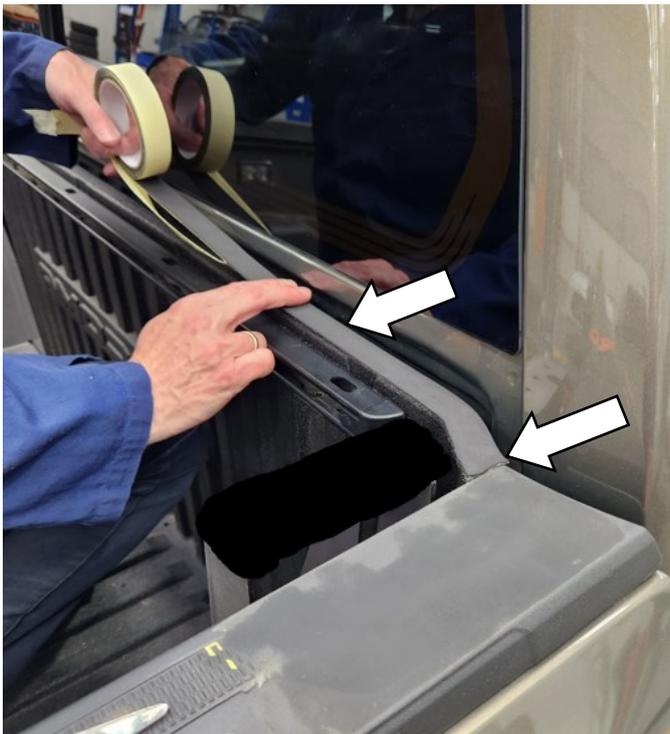
2.3) Apply foam tape (668PB018) on the front tub wall's upper face aligning the start to press up against the inner tub side walls.

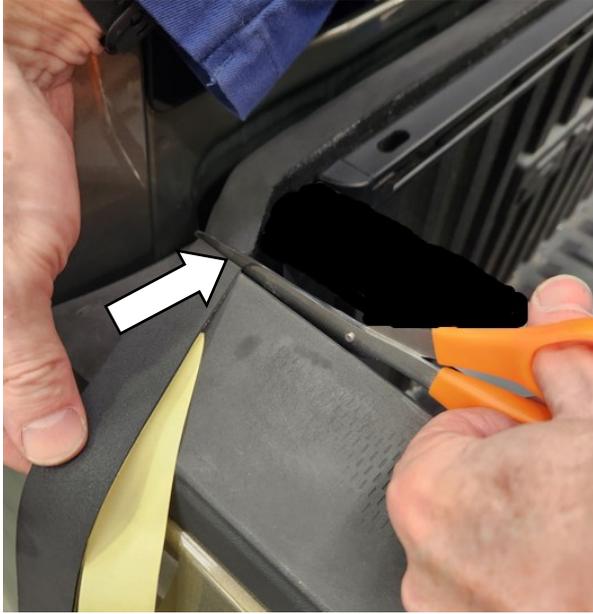
2.4) Apply to the other side and trim this to length, to press up to the inner tub's side rail wall.

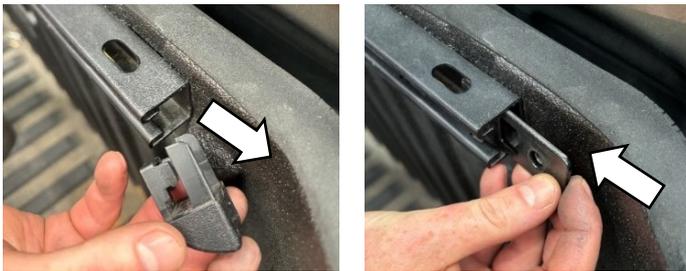
2.5) Remove the end caps from the front CMS Rail on the front wall of the tub.
2.6) Insert M8 nut plates (667AQ010) into each end of the rail with the nut side of the brackets against the tub wall's face.

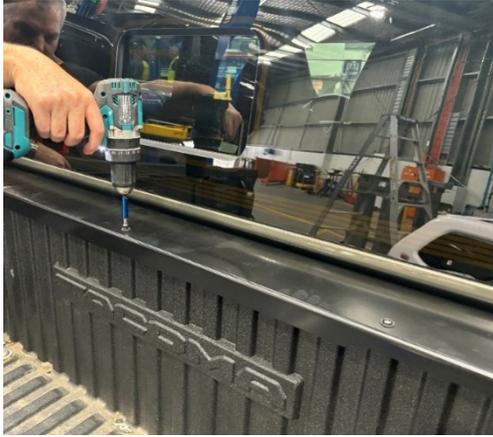
2.11) Place the upper front mount rail bracket (668PD193) down onto the front wall of the tub, so the front fold goes over the front edge of the tub between the tub and the cabin and the sides of it locate on the previously installed lower front header rail bracket assembly (668AQ007).

2.12) Insert three M6 x 16mm Torx head screws (6151859) with M6x16x1.2mm flat washers (4581082) down through the holes in the front mount rail and a screw them into the lower front header rail assembly. Ensure the upper front header rail is Central to the tub. **Tighten the M6 screws to 9Nm.**

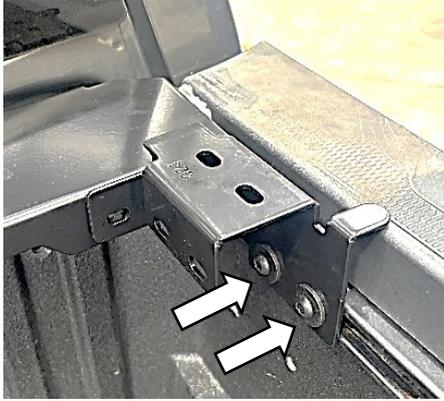
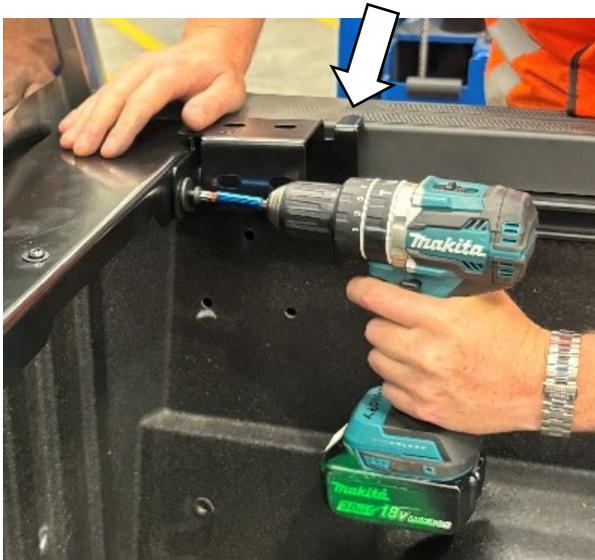
2.16) Place the respective front tub corner mounting brackets (667PD024R/L) up against the upper front header rail (668PD198) and thread the bolts into the nut plate in the side CMS rail to a **Loose fit.**

2.17) Push the tub corner mount brackets up to the upper front header rail. and assemble two Torx head screws M8 x 25 (6151625) with flat washers M8 x 25.4 x 3mm (4581303) through the two holes on the front face of the corner mount brackets through the header rail bracket (668PD193) and on the inside, behind the headed rail bracket, into an M8 nut plate (667AQ010) and tighten to a **Loose fit.**

2.18) Once assembled, **tighten the two screws to the front header rail to 20Nm** whilst ensuring the tab on the corner mount brackets with the bumpon is pushed down to engage the top of the tub. **Then tighten the side screws on the bracket to the side CMS mount rail of the tub to 20Nm.** Repeat on both sides of the vehicle.

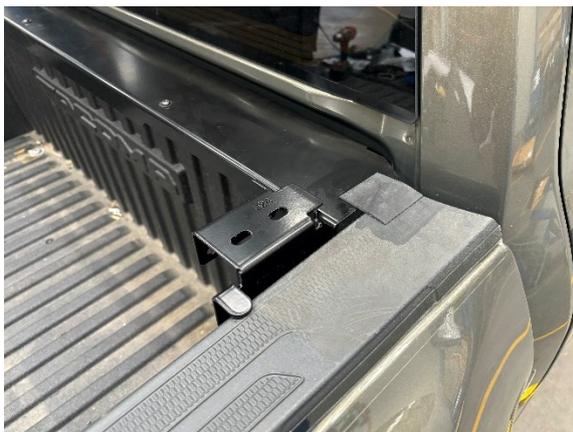
The ramp curved profile should go between the front header rail bracket and the side of the tub to act as a “bridge”.

This side to outside of tub sides

!! IMPORTANT !!
POSITION THE SEAL BRIDGE EXACTLY AS SHOWN OR FRONT CORNER WATER LEAKS COULD OCCUR

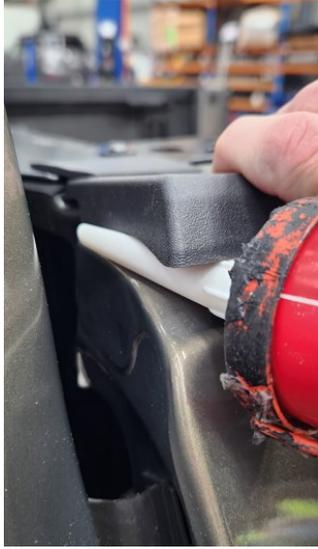
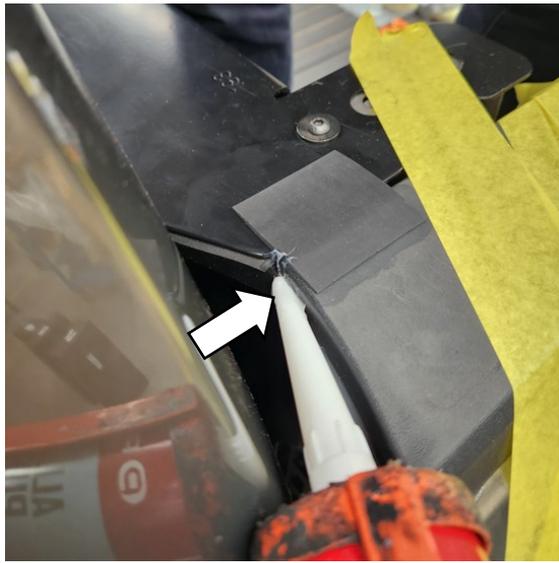
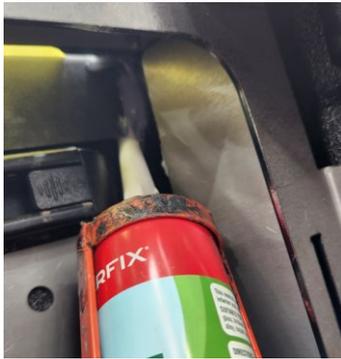
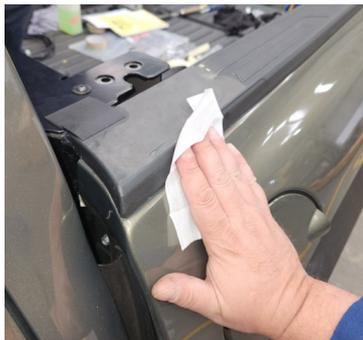
2.24) Lift the front corners of the plastic bed caps on both sides of the tub and apply neutral cure non-acetic silicone under them to create a water seal.

2.25) Apply masking tape to the front corners of the bed caps to hold them down

2.26) Apply silicone under the tub seal bridges in the area between the front tub panel and the side tub panel gaps on both sides of the vehicle

2.27) On the inside corners of the tub apply silicon up into the front corners and along underneath the tub seal bridges.

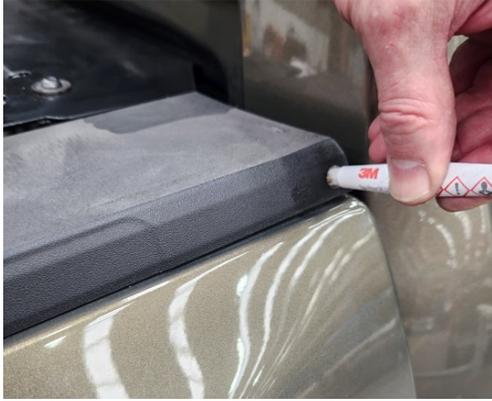
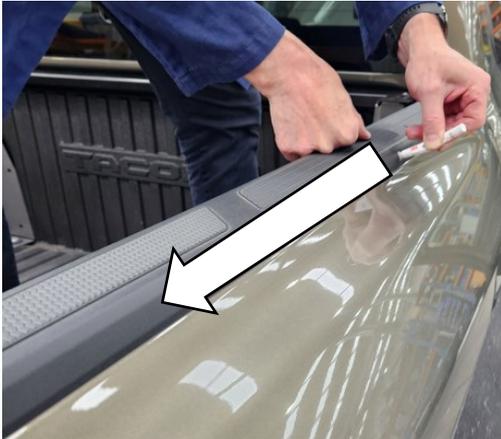
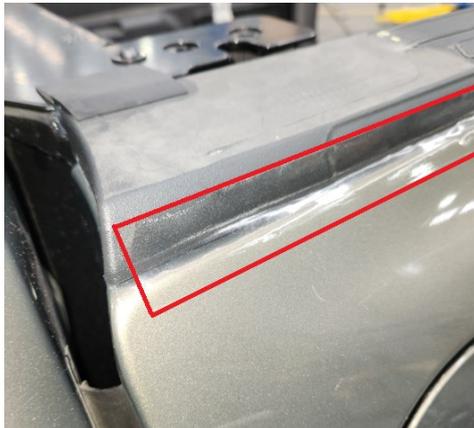
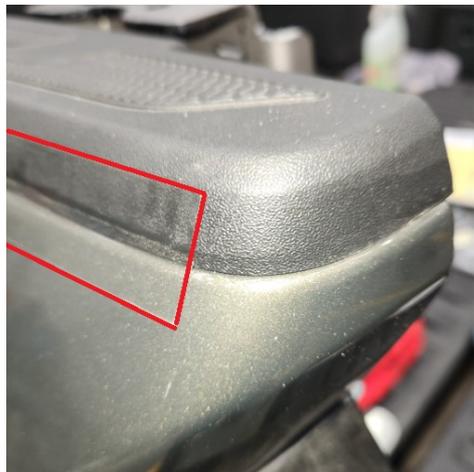
2.29) On the outside on both sides of the tub, clean along the outer faces of the bed rail caps with an alcohol wipe (6602018) and then prime them using the primer stick (665044) along the angled face of the plastic part for the length of the tub on both sides.

2.30) Apply one roll of clear tape (665037) per side of the vehicle, at the junction between the bed cap and the painted tub sheet metal. Align the centre of the tape to the junction between them.

Apply pressure along the tape and into the seam to gain good adhesion into the joint.

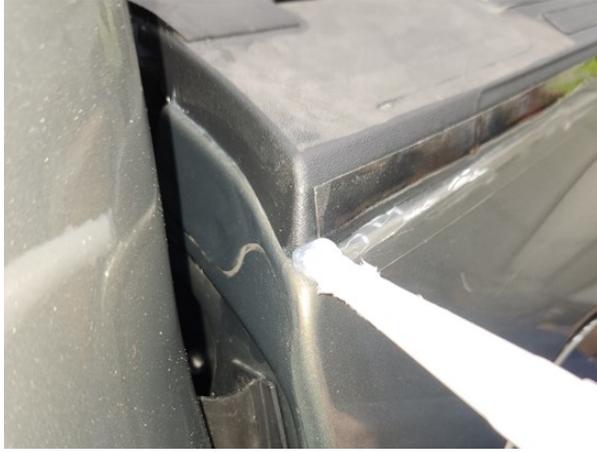
- 2.31) At the front tub corners, apply silicon along the leading vertical edge of the clear tape to aid in sealing and clean off the excess.

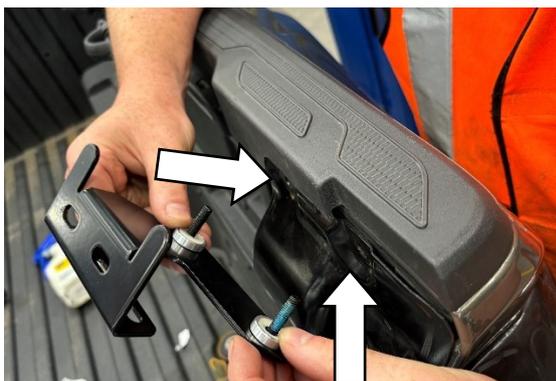
- 3.2) Fit the assembled rear tub mounting brackets (667AQ011R&L) to the vehicle's tub locating the threads of the already assembled bolts on the brackets into the threaded holes in the rear of the side of the tub.

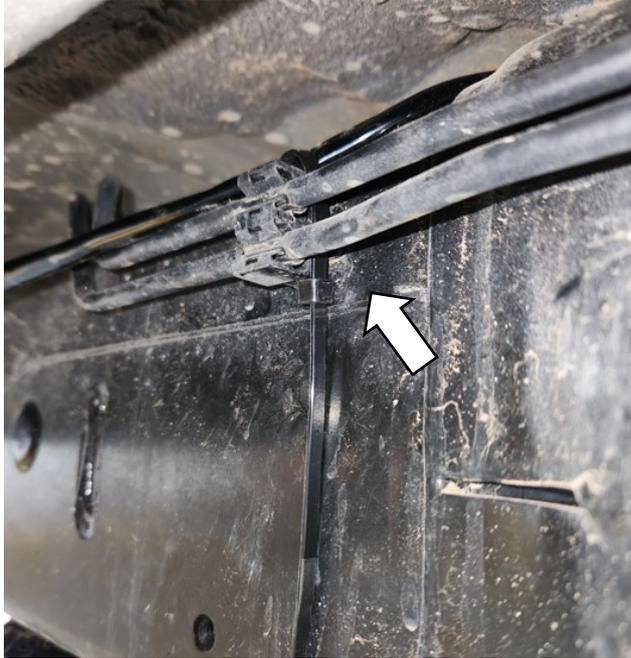
- 4.6) Route the canopy harness (667PJ005) rearward along the right-hand chassis rail. Cable tie it to the mounting bracket supporting the vehicle's brake lines.

DO NOT Cable tie to the brake lines.

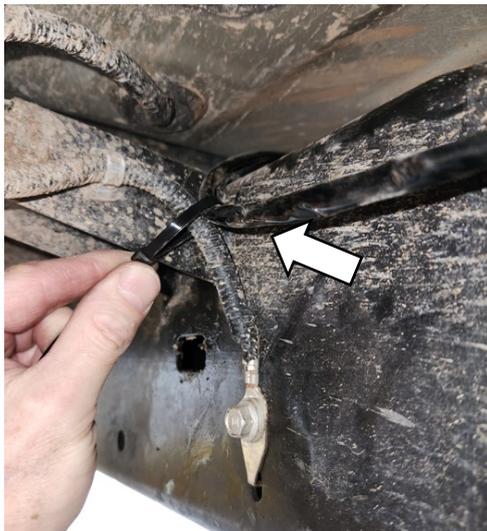
- 4.7) Running rearward, cable tie the harness to the earth loom on the vehicle.

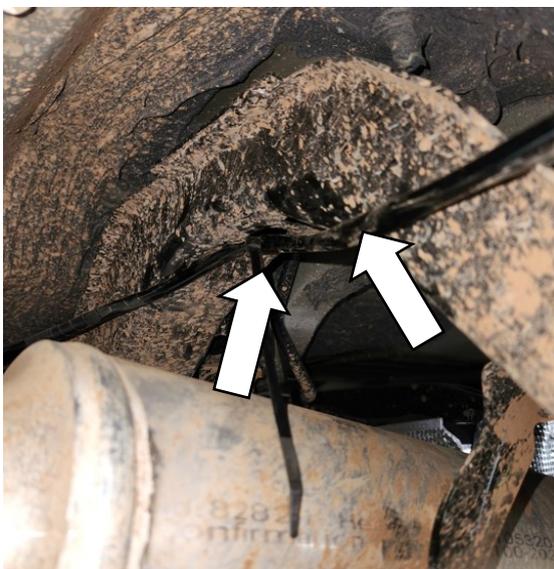
- 4.8) Cross the harness from right to left of the vehicle above the tail shaft and tie off with two cable ties above the tail shaft to the body structure above it to ensure clearance.

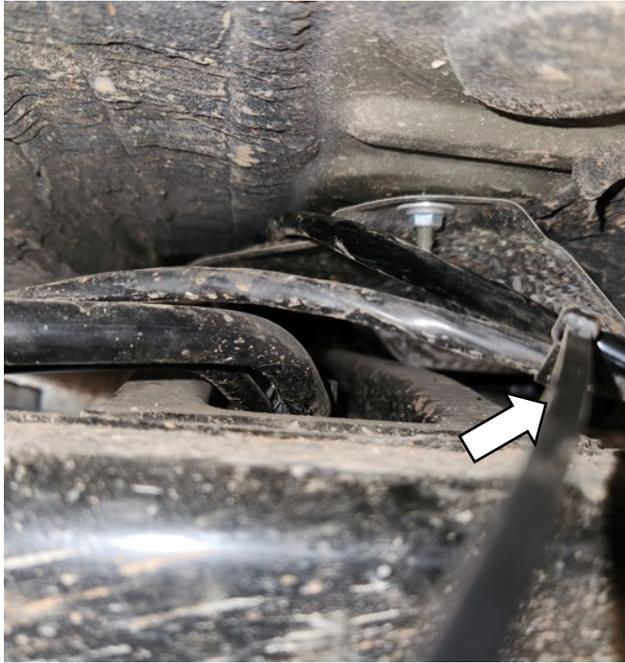
4.9) Run the harness behind the exhaust heat shielding and over to the left-hand chassis rail. Add a cable tie to secure it to the vehicle's loom in this position.

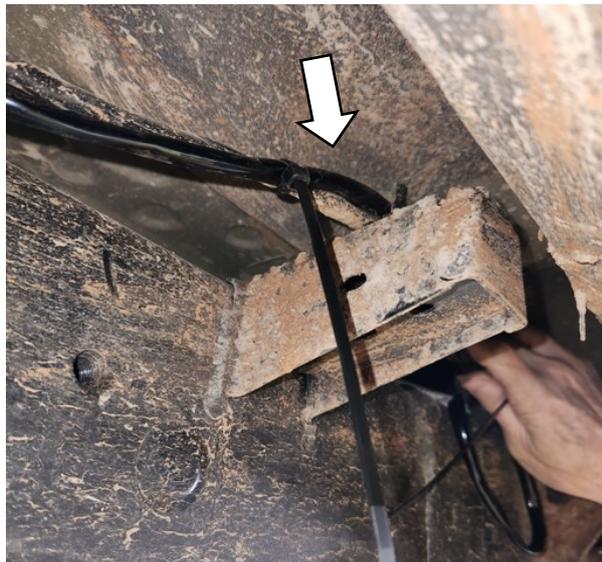
4.10) Cable tie the harness to the vehicle's loom above the body support bracket.

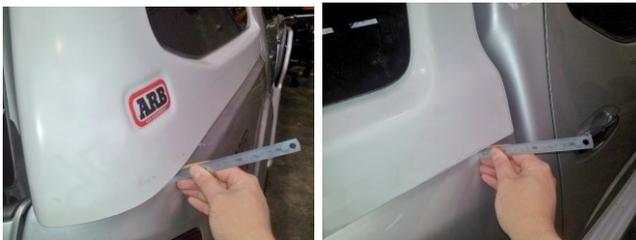
TOP VIEW OF FRONT CORNER OF CANOPY ON VEHICLE:

The canopy should be positioned so the lower door edge's sash seal is sealing well and evenly along its length to the tailgate.

Check minimum gap from canopy front pillars and cabin is 20mm minimum at the closest point of the pillar to the vehicle's cabin.

Check the front lower corners of the canopy are aligned to the beginning of the edge radius at the front of the tub.

Measure the trim edges of the canopy at both the front and rear sides, to the vehicle's tub.
This measurement should be even on both sides of the canopy.

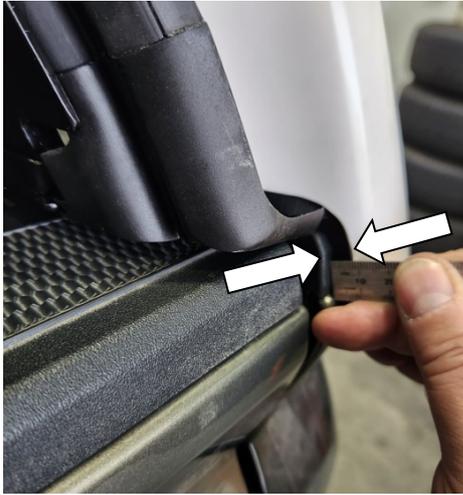
Check the gap of the canopy shell's rear trim edge corners to the tub. It should be even on both sides of the canopy.

!! IMPORTANT !! The gap between the rear pillar corner piece should be 7mm or more and even both sides

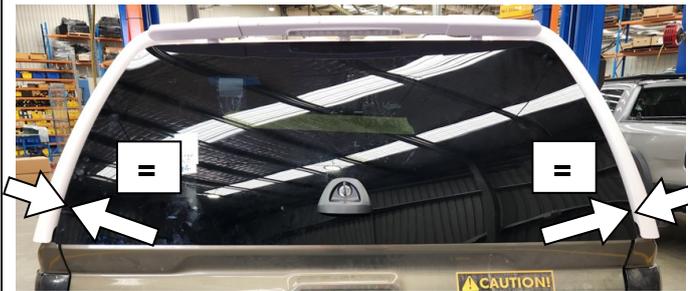
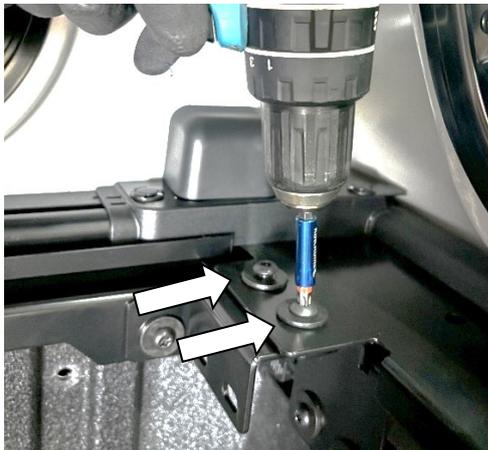
- 5.5) Assemble two M8 x 25mm T40 Torx head screws (6151625) with M8 x 25.4 x 3mm flat washers (4581303) down through the front corners of side base rails of the canopy, through the front tub corner mounting brackets (667PD024R&L). On the underside locate an M8 Nut plate (667AQ010) to screw the screws into
Tighten M8 screws to 20 Nm.

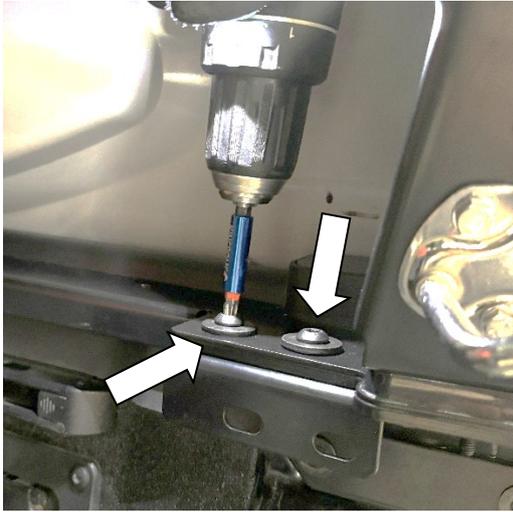
- 5.6) Assemble two M8 x 25mm T40 Torx head screws (6151625) with M8 x 25.4 x 3mm flat washers (4581303) down through the rear corners of side base rails of the canopy, through the rear tub mounting brackets (667AQ011R&L). On the underside locate an M8 Nut plate (667AQ010) to screw the screws into
Tighten M8 screws to 20 Nm.

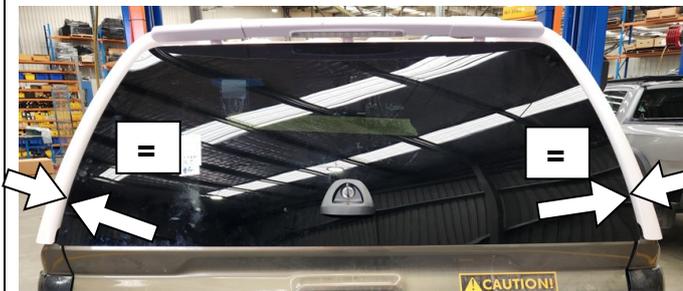
5.16) It may be necessary to adjust the canopy backwards to reduce the pressure on the lower door seal and actuator mechanism. This will allow the door to open properly and evenly both sides.

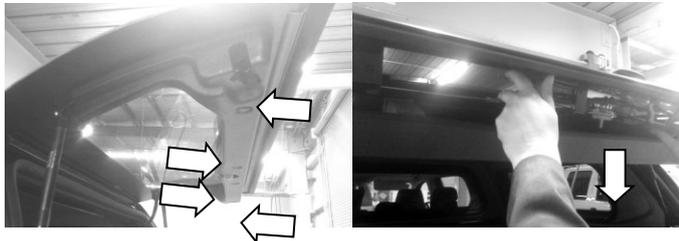
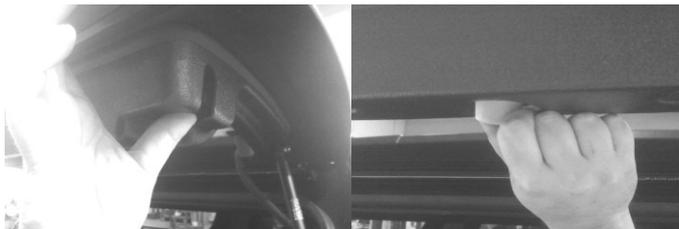
6.3) Operate the door push button switch to open and close the door. **If one side opens before the other, the lock mechanism can be adjusted so that both sides of the door open simultaneously if the following is done:**

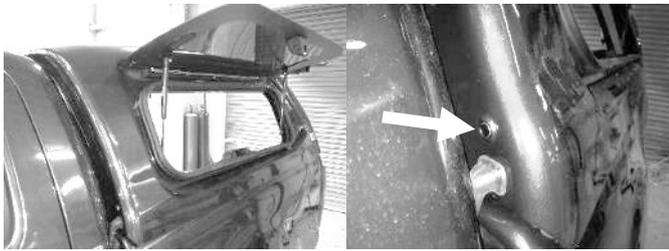
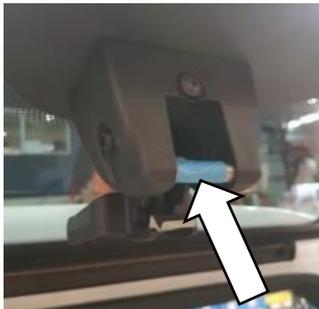
6.4) Operate the push button switch on side lift-up windows. If the windows will not latch properly, and the solenoid can be heard working, the latch can be adjusted in the following steps.

- Remove the rotary latch cover on the window frame.
- Operate the window with a person outside pushing the button and closing the window slowly. Look to see the striker bar on the glass does not scuff the leg on the rotary latch pawl as the window closes. The striker bar should close into the middle of pawl slot on the rotary latch on the frame. Place one thickness of masking tape around the striker bar where the latch contacts. Open and close the window. If the tape shows signs of wear through on the top or underside of the striker bar, it is necessary to adjust the striker away from the side on which the wear is shown. **The aim is only to have wear on the outward side of the striker bar not above or below in closed position.**

- The rotary latch on the window frame provides window in/out adjustment. Measure the distance between the back of the rotary latch and it's mounting bracket and take note of it (9mm). Loosen the bolts through the latch and move the latch out 1mm at a time and **re-tighten to 9Nm** and test the window until it opens and closes and seals satisfactorily.
