DUAL CAB CENTRAL LOCKING CANOPY

Ascent Canopy USA ONLY AC24CXX – Ford Ranger Dual Cab 2024
(2024 Vehicle Production Onwards. Fits XL,XLT, Lariat, Raptor)

FITTING KIT: TAILGATE AND HEAD BOARD KIT 6178556. TUB MOUNT KIT 6178688

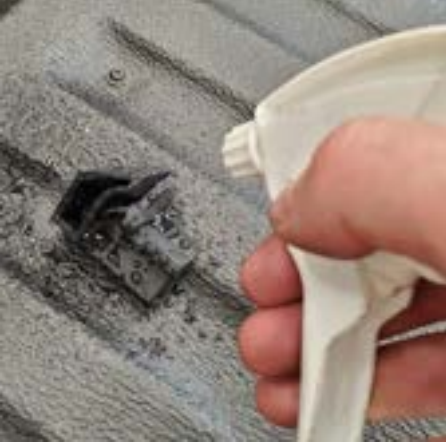
<div style="border: 1px solid black; padding: 5px; margin-left: 10px;"> <p>SPRAY 668PE057R WITH SOAPY WATER</p> </div> </div> <div style="display: flex; align-items: center; margin-top: 10px;">

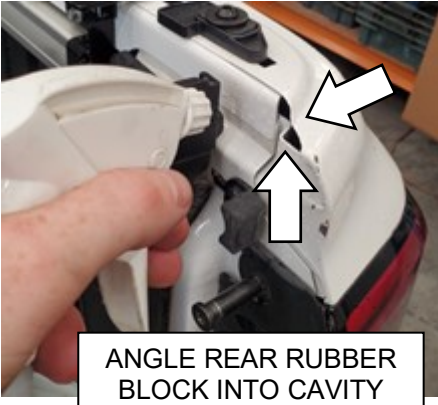
<div style="border: 1px solid black; padding: 5px; margin-left: 10px;"> <p>SPRAY CAVITY WITH SOAPY WATER</p> </div> </div> <div style="border: 1px solid black; padding: 5px; margin-top: 10px; width: fit-content;"> <p>ANGLE REAR RUBBER BLOCK INTO CAVITY</p> </div> </div>	<p>2.1) Take rear tub rail sealing block (668PE057R) and spray with soapy water.</p> <p>2.2) Spray the rear corner hole in the top tub rail at the back of the vehicle with soapy water.</p>

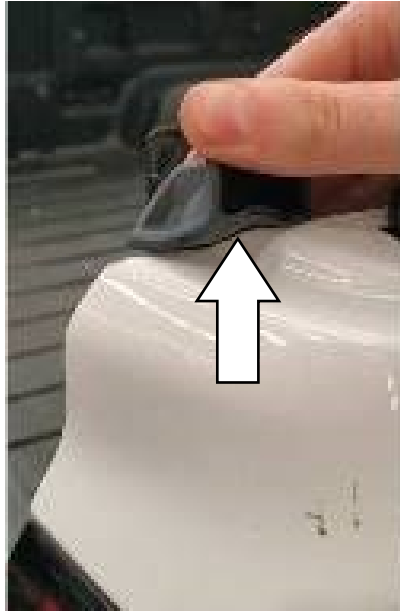
CHECK CLIPPING LIP IS UNDER TUB SHEET METAL

2.4) Work the clipping lip of sealing block under the tub sheet metal top skin, by pushing the block back and forwards whilst pushing it inwards.

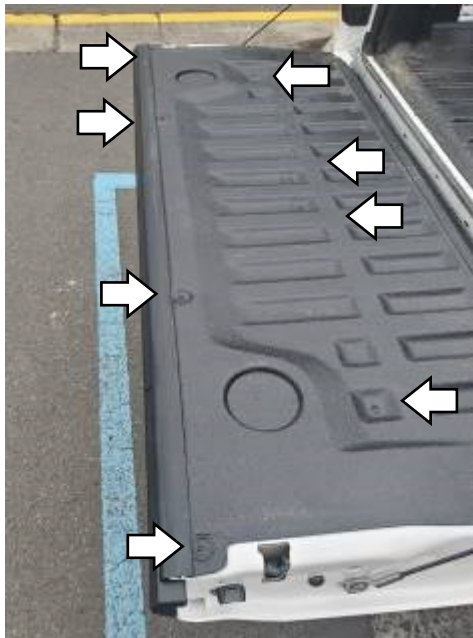
REMOVE ALL
SCREWS AND
TAILGATE
LINER

2.7) If the tailgate plastic liner is present, remove all the T20 Torx drive screws and retain for refitment.

2.8) Remove the complete tailgate liner and retain it whilst leaving the rubber upper and lower extrusions in position.

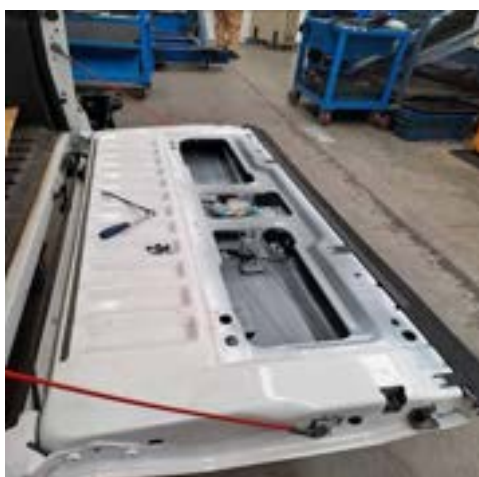
2.9) Remove the metal inspection panel on the inside of the tailgate and retain it with it's screws for refitment later.

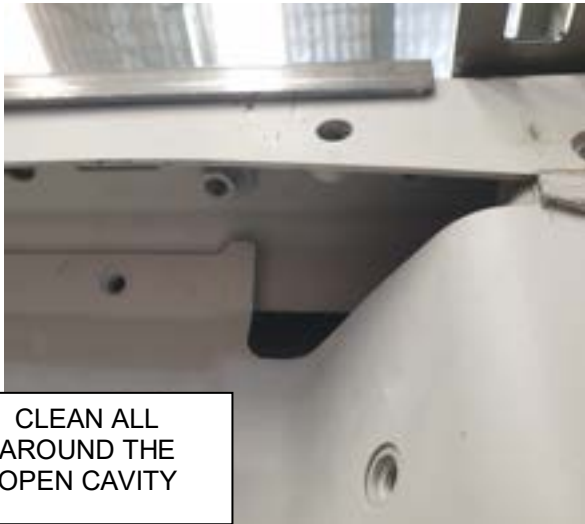
Note: For clarity, the CMS side track rails has been removed from the tub.

3.1) Locate the open cavity under the upper front left-hand corner of the tub and clean with an alcohol wipe (6602018).

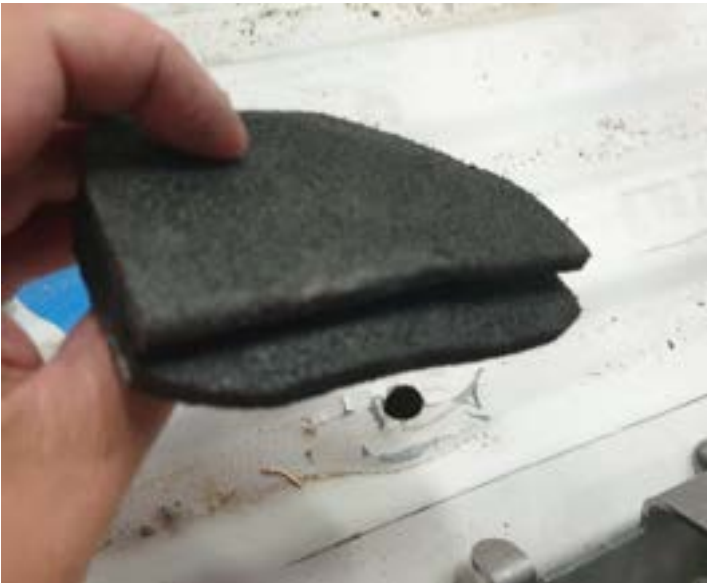
3.2) Take the left-hand foam block as per opposite from the pair of 668PB033.

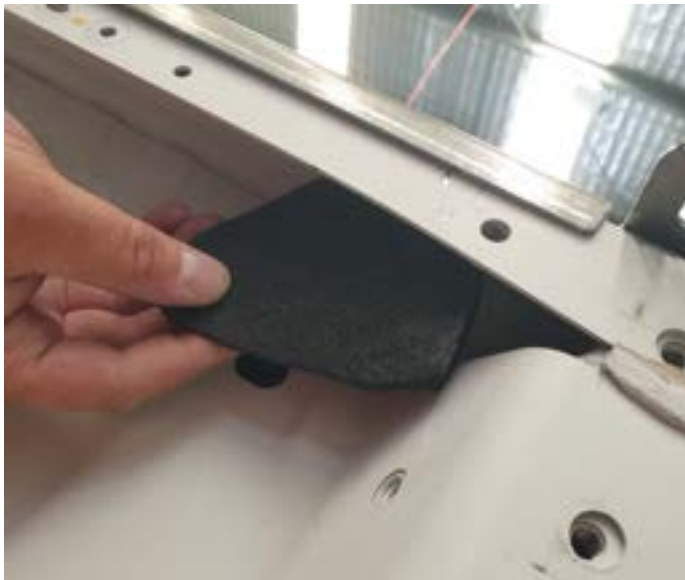
3.3) With the grooved recess edge facing down, push the foam block up into cavity opening with recessed edge, with its short leg side to clip over the tub sheet metal edge on the front pillar cavity of the tub.

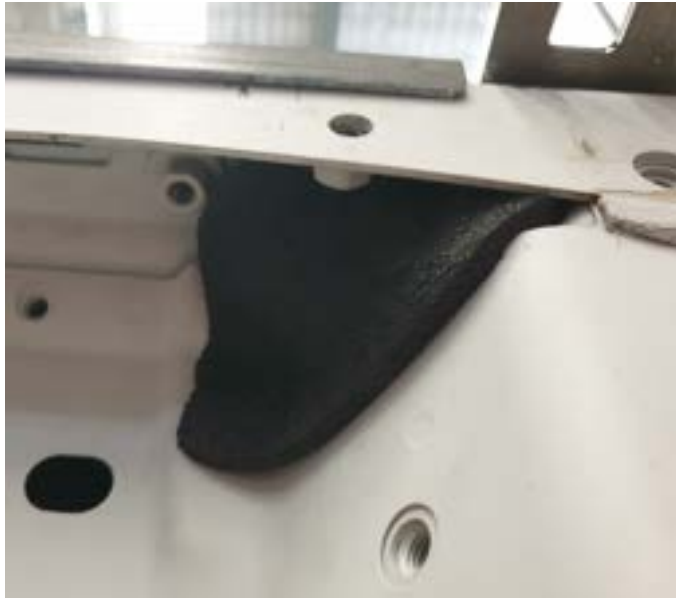
3.4) The foam sealing block is to be an interference fit with the underside of the side tub rail and fit firmly in place as shown. Position the top edge of the foam block to avoid covering weld nuts in the tub.

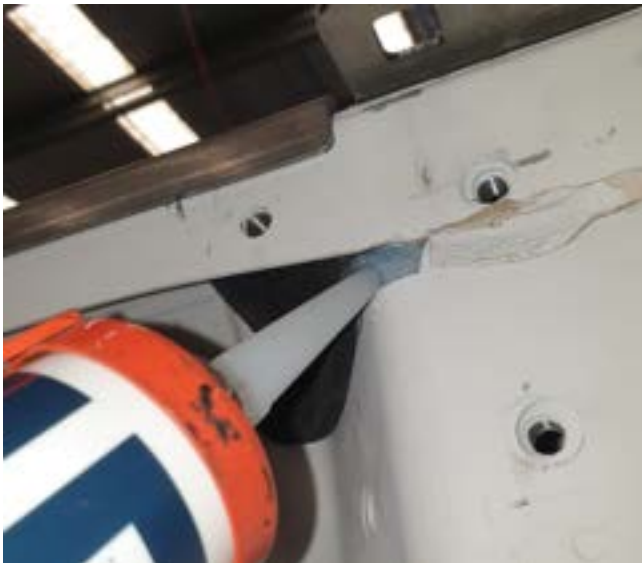
3.5) Use neutral cure non-acetic silicon to fill gaps and seal edges all around foam block and tub.

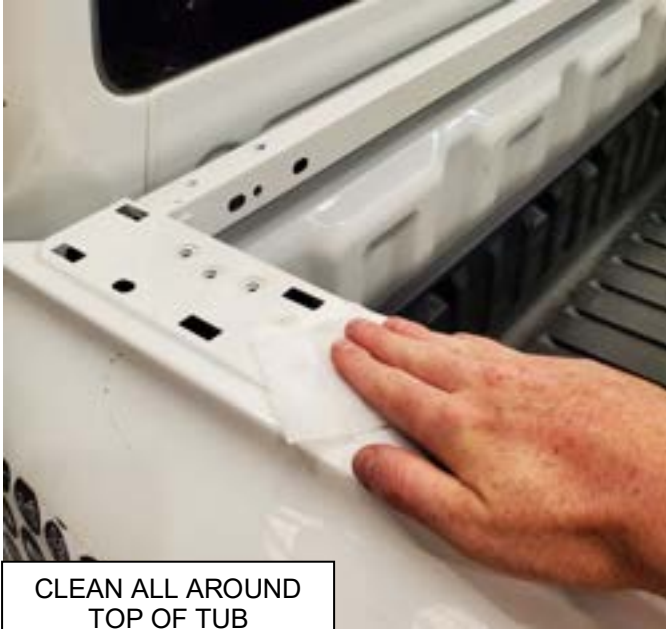
4.0) Use alcohol wipes (6602018) to clean the side top rails of the tub and front tub rail.

PLACE BLACK STICKERS OVER RECTANGULAR FRONT SIDE RAIL CORNER INNER HOLE AND TWO HOLES ON THE FRONT VERTICAL FACE OF TUB PER SIDE

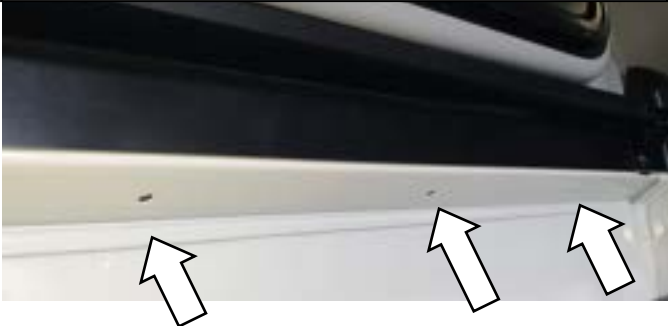
6 HOLES UNDER THE FRONT TUB RAIL TO BE SEALED IF BEDLINER IS REMOVED

- 4.5) Under the front tub rail, the angled face has 6 holes **if a bedliner is removed**. The 6 holes in the tub need to be sealed. Over 6 fir tree clips (6152128) assemble rubber washers (4584435) under the head of the fir tree clips. Then install them into the vehicle's front tub rail.

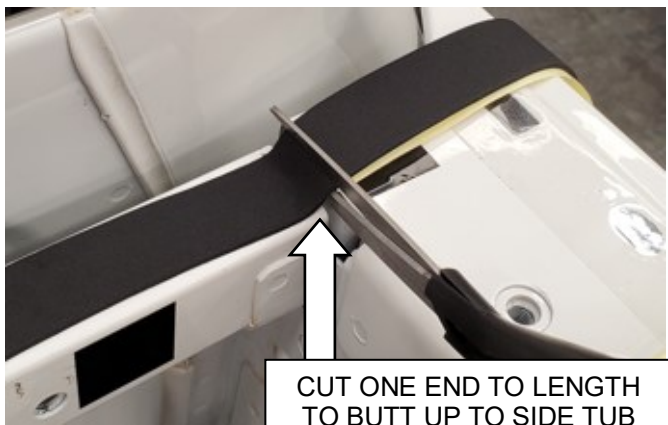
- 4.6) Assemble adhesive foam tape (668PB018) and mate the starting edge tightly against the side tub rail and run it along top face of the tub front rail, centrally. Ensure the holes in the upper surface of the front tub rail are covered and well-sealed by the foam tape. Cut the tape to length and mate the end up firmly to the side tub rail on the opposite side.

CUT ONE END TO LENGTH TO BUTT UP TO SIDE TUB

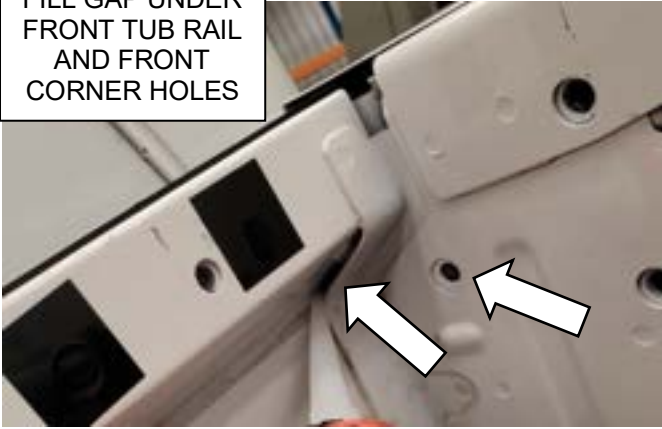
FILL GAP UNDER
FRONT TUB RAIL
AND FRONT
CORNER HOLES

FILL GAP FRONT
CORNERS OF TUB

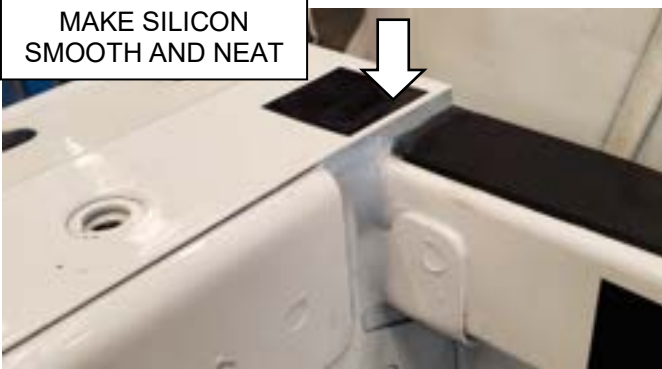
PLACE X2 SILICON
BUMP STOPS

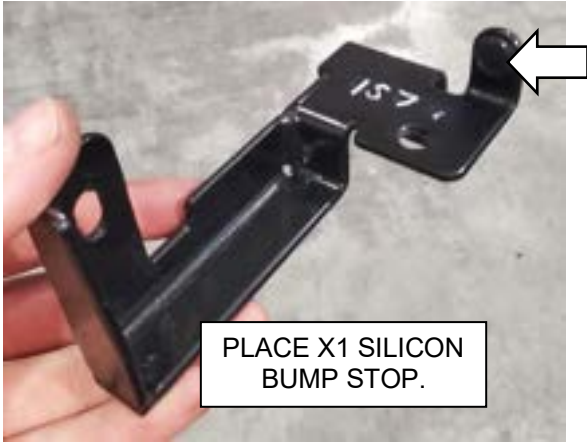
4.9) **Take front tub corner mounting brackets (668PD167R/L) and place two bump on clear circular pads (665076) to the tags on the brackets as shown.**

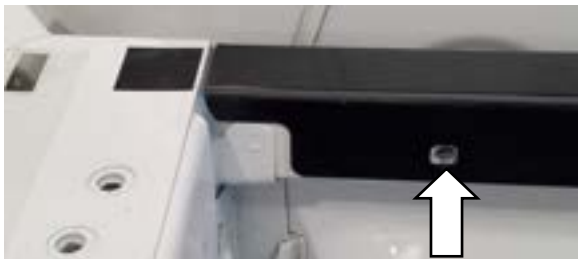
4.11) Place the front mount rail bracket (668PD156) over the front tub rail. Align the bracket to center and align it with the with threaded holes in the front face of the tub on each side. Ensure there is an even gap between the ends of the bracket to the side rails of the tub.

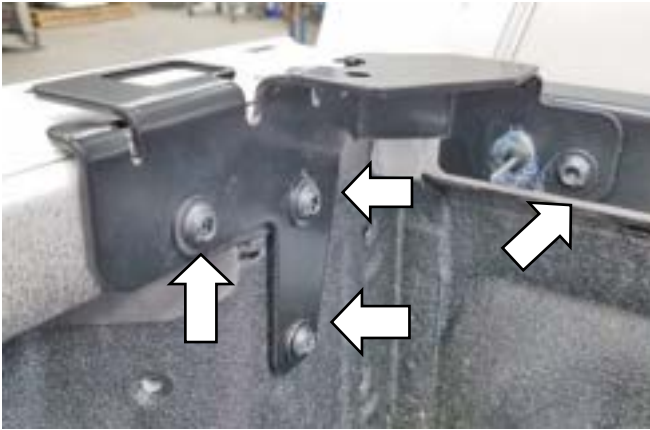
TIGHTEN TO 20Nm

4.13) Locate the front corner mounting brackets (668PD167R/L) to the front corners of tub.

Per bracket, take four M8x25mm Torx screws (6151625), with M8x19x1.2 washer (4581085) and finger tighten these through the bracket to the tub first.

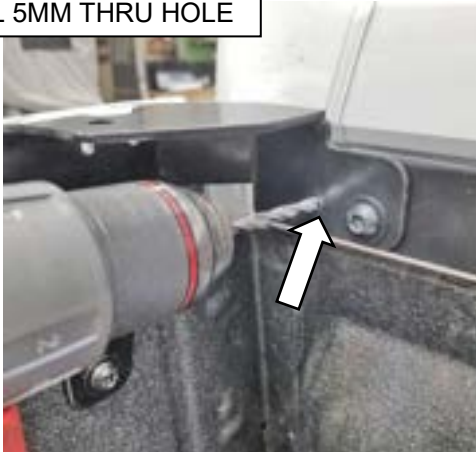
DRILL 5MM THRU HOLE

4.14) Drill a 5.2mm hole through the existing hole in front corner mounting bracket where it meets the front tub rail and drill through the front tub rail.

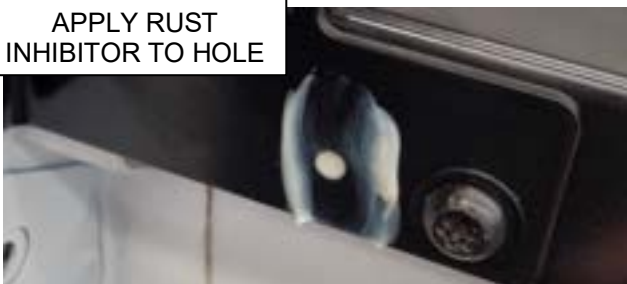
APPLY RUST INHIBITOR TO HOLE

4.15) Apply rust inhibitor 665505 to drilled hole.

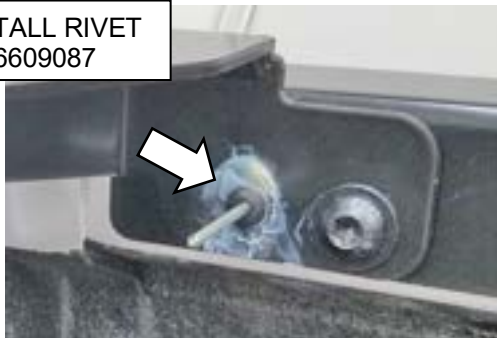
INSTALL RIVET
6609087

4.16) Install rivet (6609087) to the drilled hole.

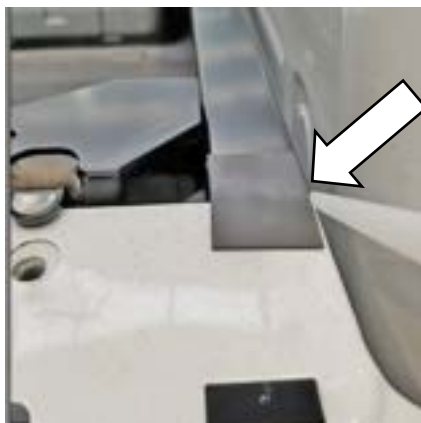
APPLY SILICON TO EACH SIDE OF BRIDGE FRONT AND BACK

4.22) Apply clear neutral silicon to the edges of bridge seal as shown. Wipe clean and make neat.

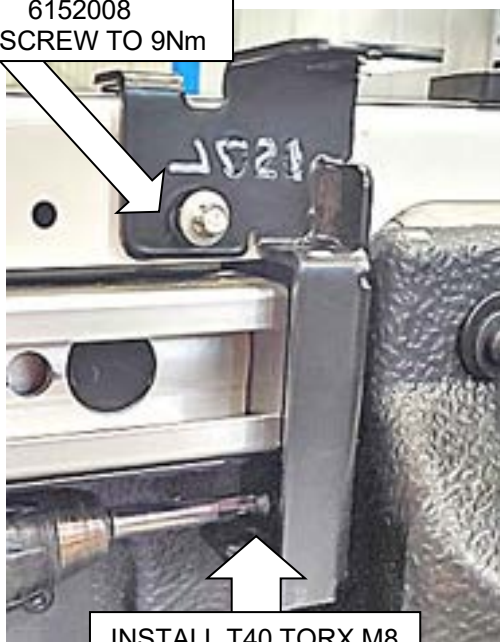
6152008
M6 SCREW TO 9Nm

INSTALL T40 TORX M8
SCREW TO BOTTOM
BRACKET

4.24) If CMS cargo tie down rails are fitted, locate the rear tub mount bracket (668PD157R) over tub lip where the tag with bumpon engages the top face of the side tub rail **and push down so it engages on the bumpon** and the lower end of the bracket meets up to the face of the bracket supporting the CMS track.

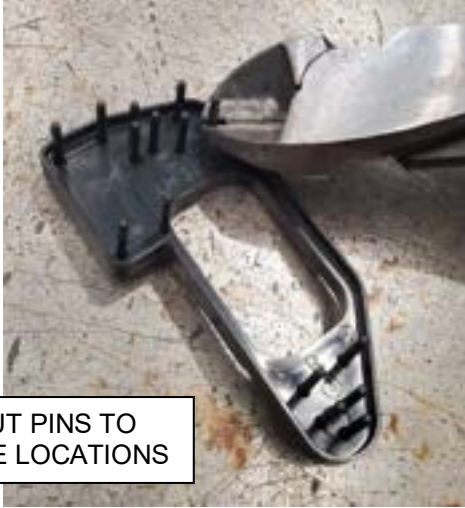
4.29) View the side with the spigots of the plastic spacer locators tub rail (668PE051R/L) and cut off spigots as marked on underside of spacer.

“M” (for middle position)

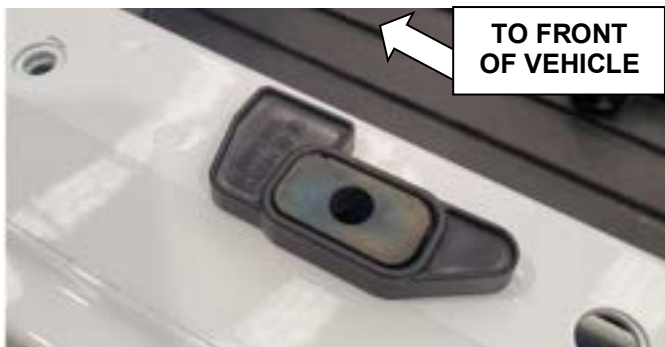
M LOCATOR AND SPACER POSITION AT MIDDLE OF TUB

- 4.30) Once the spigots have been cut off and per position location on the tub (Middle or Rear), place spacer locators 668PE051R/L along tub lip (2 LH parts to LH tub rail and 2 RH parts to RH tub rail top surfaces).
- 4.31) Position these Middle and Rear. See images. The spigots on the locators locate into existing holes in the tub corresponding to their position on the tub.
- 4.32) Then place inside 668PE051R/L spacer locators a total of 4 (668PD151) rectangular spacers that are 10mm thick.
- 4.33) Through the front corner mount brackets (668PD167R/L) place of 2 (668PD151) rectangular spacers that are 10mm thick.(1 per side).

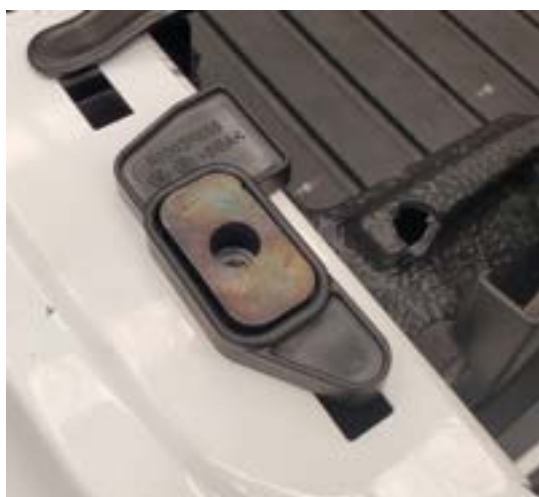
R LOCATOR AND SPACER POSITION AT REAR OF TUB

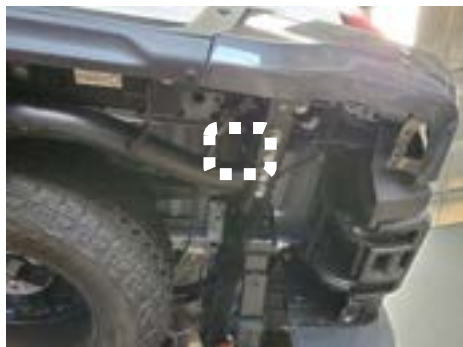
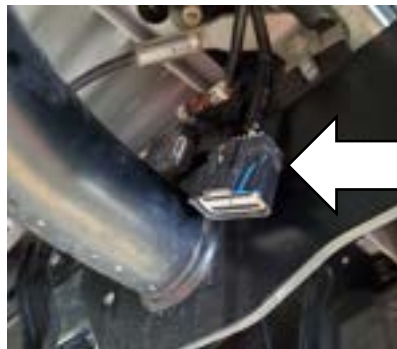
DISCONNECT 16 PIN ELECTRICAL CONNECTOR

5.4) Put the car on hoist and start at the underside rear RH corner of the chassis rail.
5.5) Locate and disconnect the 16 pin OE connector as pictured.

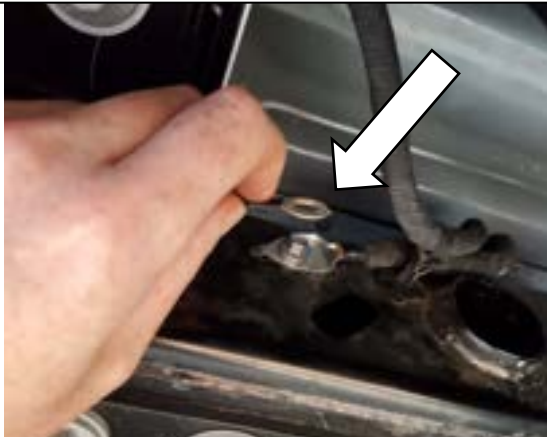
ON XL,XLS,XLT, WILDTRACK

FASTEN EARTH TERMINAL TO EXSTING M6 SCREW ON CHASSIS RAIL TO OUTSIDE

5.7) **ON XL, XLS, XLT, WILDTRAK ONLY** Locate the earth screw on RH chassis rail on the outside of the rail and undo it with an 8mm socket. Reinstall the M6 screw with earth eyelet attached from the 668PJ031 canopy loom.

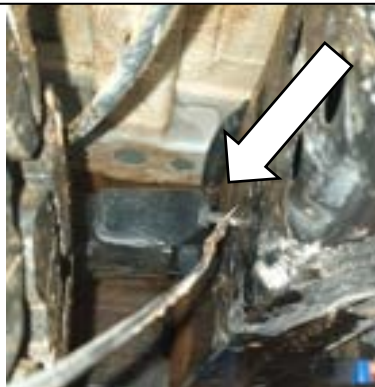
ON RAPTOR

FASTEN EARTH TERMINAL USING M6 SCREW FROM KIT ON CHASSIS RAIL TO INSIDE

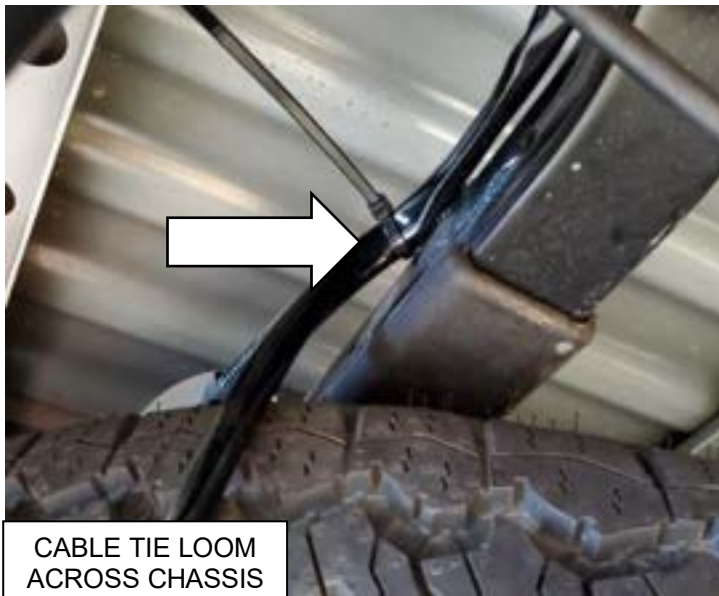
CABLE TIE LOOM ACROSS CHASSIS

5.10) Follow the vehicle loom across the width of the vehicle's chassis to LH side behind the spare tyre and cable tie the canopy loom to it before the spare tyre.

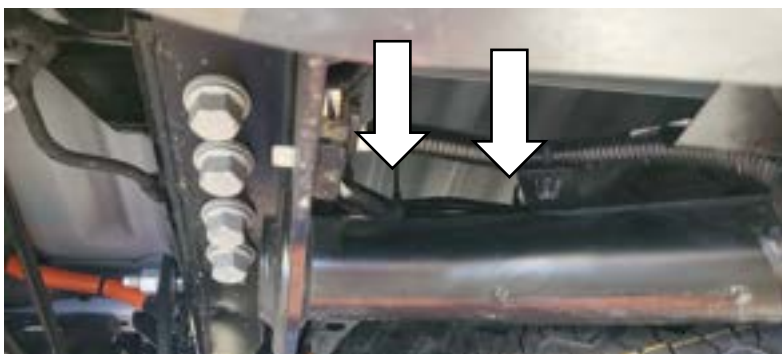
5.11) Cable tie off canopy loom to the vehicle's loom above the spare tyre and at the chassis junction of the cross member to the LH side chassis rail (2 cable ties used).

CABLE TIE LOOM ACROSS
LH CHASSIS RAIL

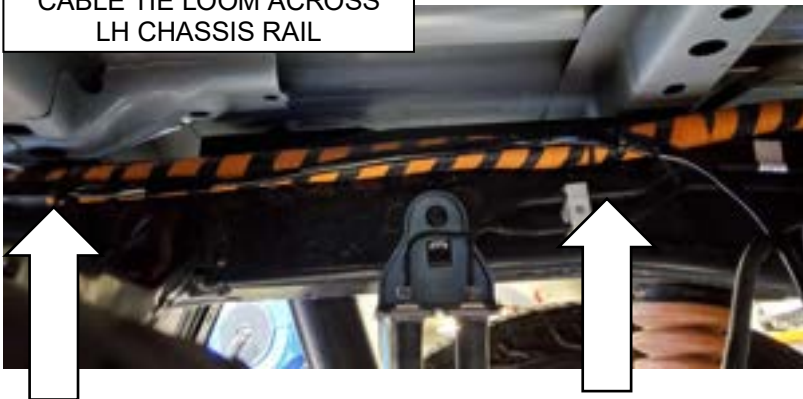
5.12) On inner side of LH chassis rail, locate the vehicle's wiring loom and lead the canopy loom towards the front of the vehicle and cable tie in two places rearward of the LH rear wheel bump stop.

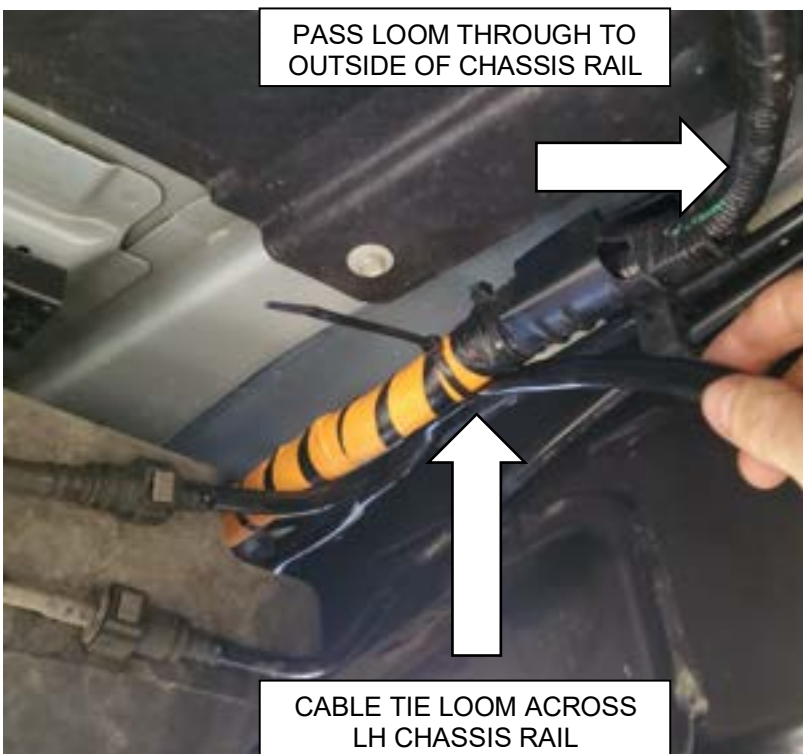
PASS LOOM THROUGH TO
OUTSIDE OF CHASSIS RAIL

5.13) Cable tie off the canopy loom again at 3 places to the vehicle's wiring loom before it reaches the location where the vehicle's loom crosses over the top of the LH chassis rail.

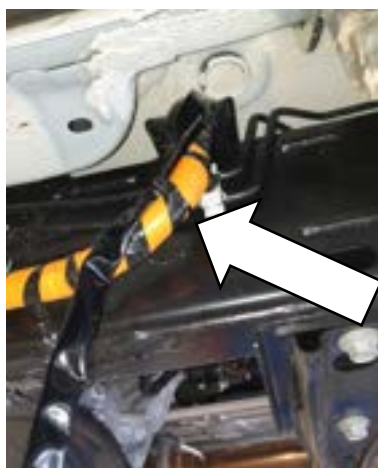
5.14) Pick up vehicle's loom on the outside of the LH chassis rail and secure the canopy loom to the vehicle's loom with a cable tie at the bend.

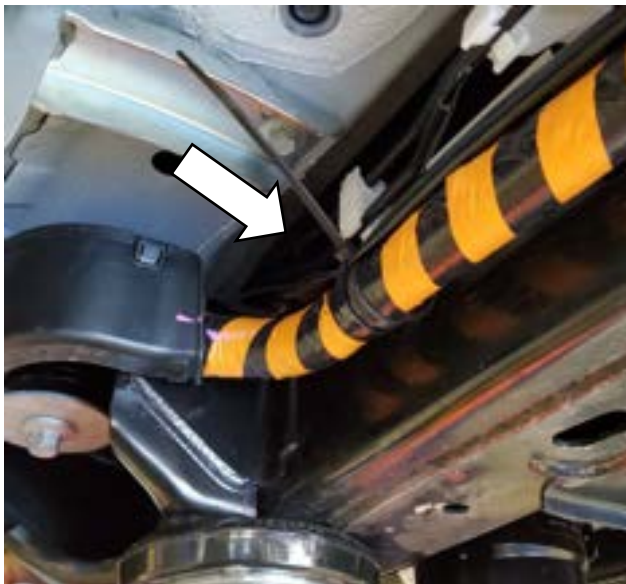
5.15) Cable tie off the canopy loom with 3 more cable ties to the vehicle's loom as it heads forwards towards the plastic cable track behind the front LH wheel near the body mounting.

5.16) Pass the canopy loom between the chassis rail and the body floor (behind the body mount), ensuring all forward connectors and fuses are orientated to fit through the cavity.

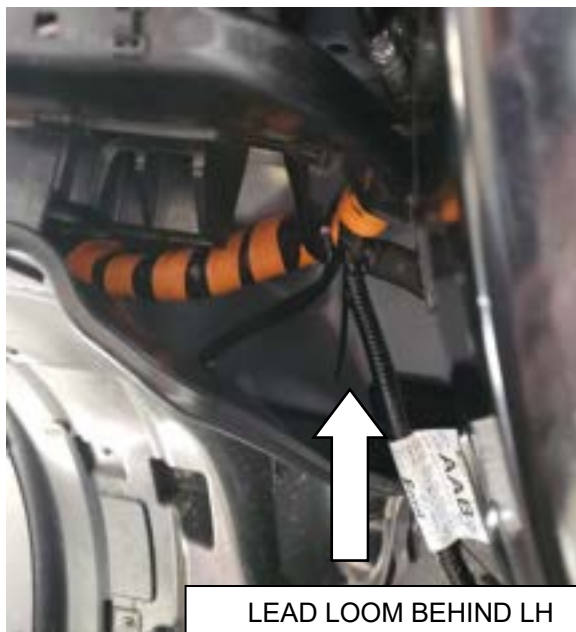
LEAD LOOM BEHIND LH FRONT WHEEL ARCH LINER

5.17) Lead the canopy loom through to the front LH front wheel arch liner and cable tie off to vehicle's main loom at the bottom

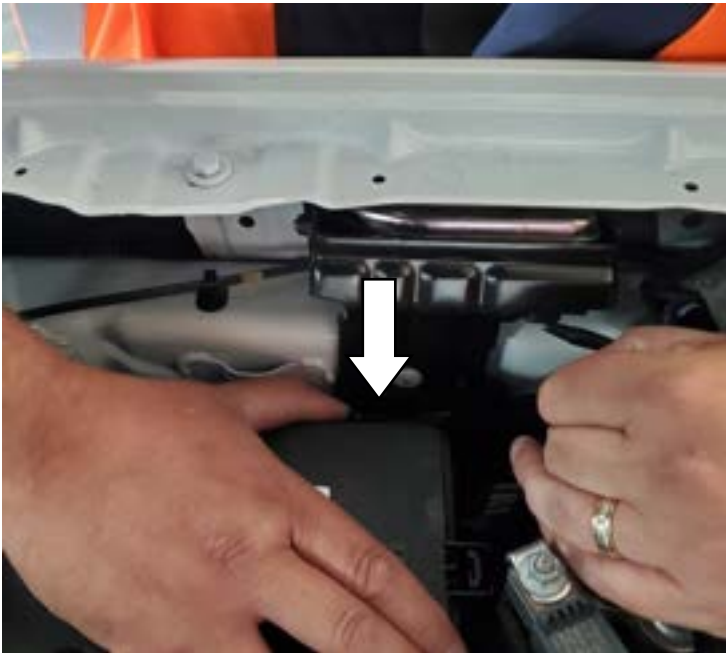
5.18) Open the bonnet and thread the canopy loom up through behind the LH wheel arch liner to the front corner of engine bay, behind the fuse box.

5.19) Push loom down as far down as possible behind the fuse box and pull it forward to the cavity between the battery and the fuse box.

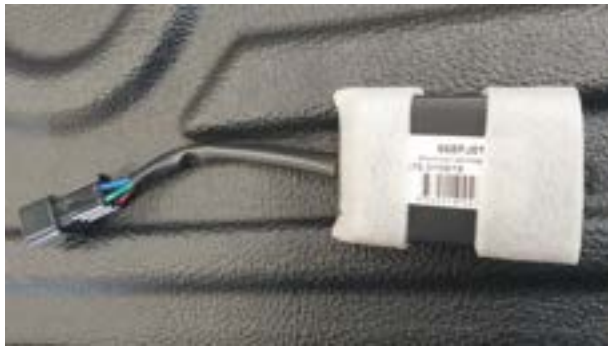
5.22) Use (668PB015) anti-rattle foam strips and apply in the two positions shown on the (668PJ015) latch relay.

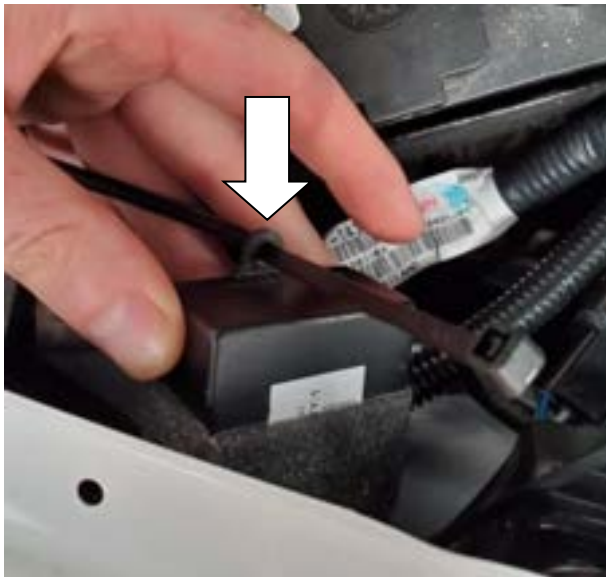
5.24) Locate the vehicle's bracket under LH lip of the front fender. This will be used to tie off the relay box to.

5.25) Loop a cable tie through hole in one end of the relay box.

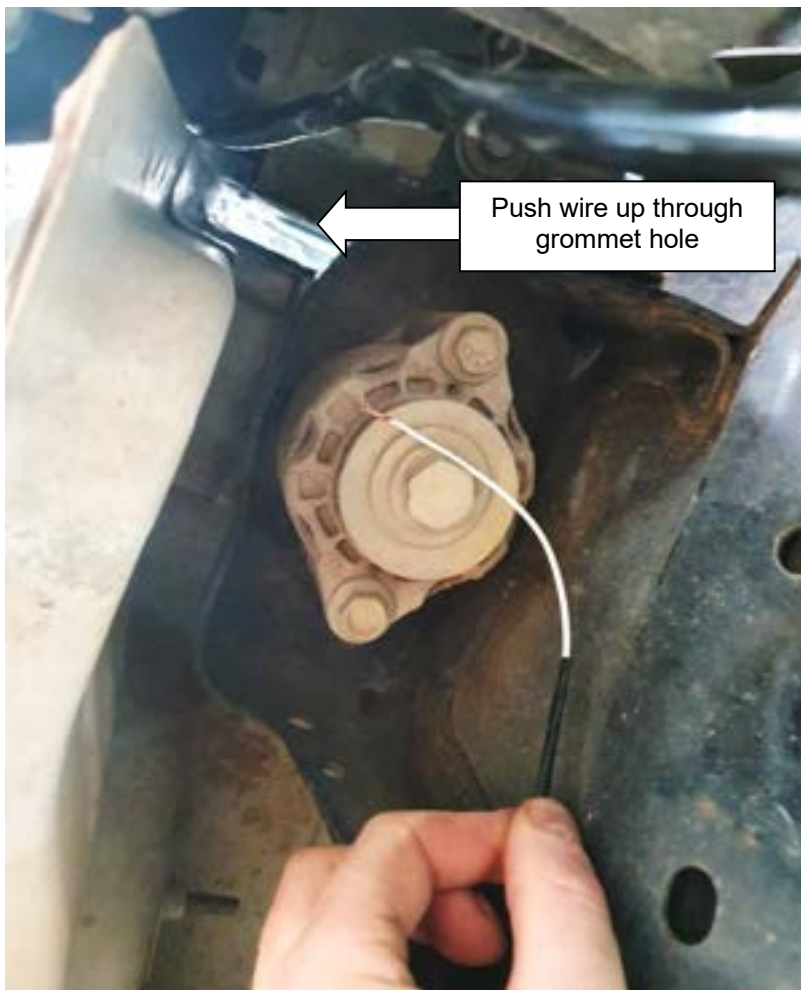
5.30) With a knife make small slit in centre grommet. This will be used to thread wire through.

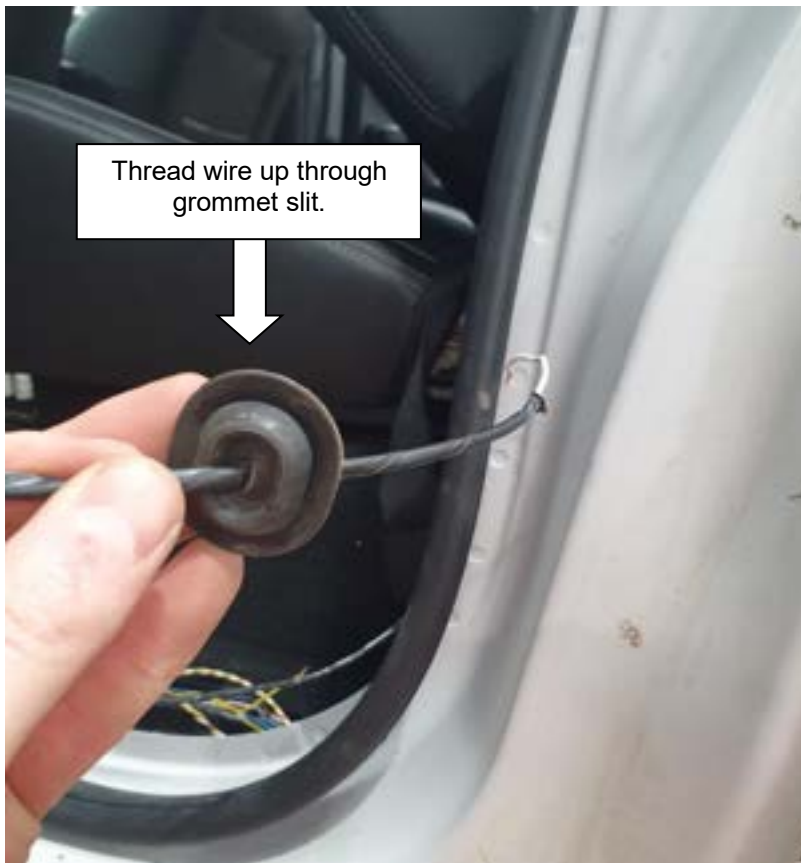
5.32) Thread the canopy loom brake light wire through grommet hole until taugt.

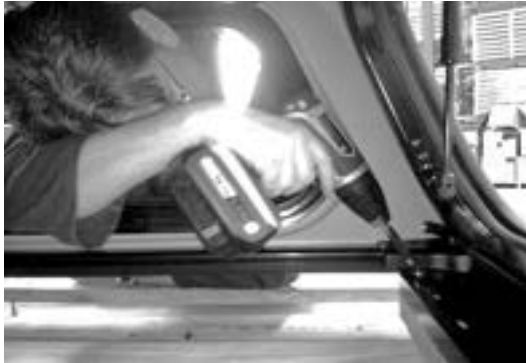
- 6.1) Unscrew the canopy on the pallet by removing the 4 wood screws in each corner. Gain access to screws via opening the rear door and front lift up window
- 6.2) The front lift up window can be unlatched by reaching in underneath the canopy on the pallet and pushing forward on the glass in car position, to push the latch button upwards on both latches to unlock the window.

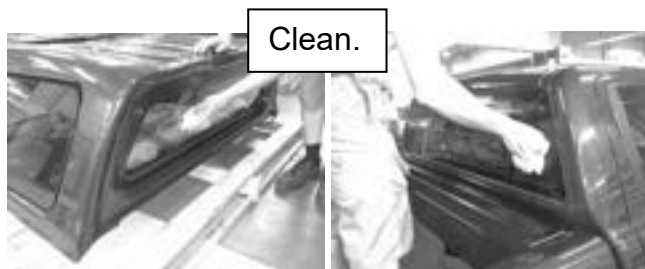
- 6.3) Clean the front window of the canopy on the outside.
- 6.4) Clean the rear window of the vehicle's cabin.
- 6.5) Close the vehicle's tailgate.

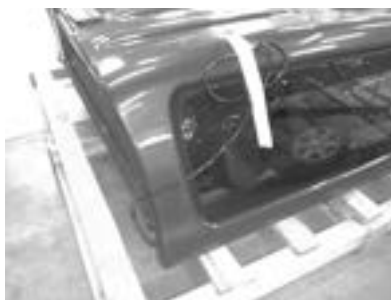
- 6.6) Cut the cable tie holding the wiring harness to the window frame bracket inside the front corner of the canopy. Using masking tape, tape the harness up over the front LH corner of the canopy.

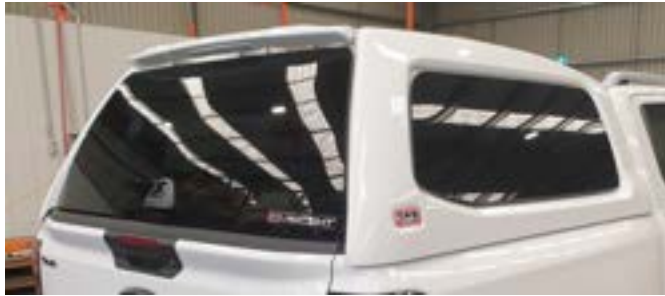
TOP VIEW OF FRONT CORNER OF CANOPY ON VEHICLE

Front lower trim edge of shell to align to edge radius at front of tub

Vehicle tub front corner

Canopy shell

6.7) Close the canopy's rear door and **USING 4 PEOPLE**, lift the canopy from the pallet and place it carefully down onto the vehicle's tub

POSITIONING OF CANOPY ON TUB:

The canopy should be positioned so the lower door edge's sash seal is sealing well and evenly along its length to the tailgate door stop extrusion assembly mounted on the vehicle's tailgate and even side to side so the tailgate closes with clearance between the door frame seals at the sides of the canopy.

Then review the front leading lower edge corners of the canopy are aligned just to the beginning of the edge radius at the front of the tub.

Check minimum gap from canopy front pillars and cabin is 20mm at the tightest location on the hip of the front pillar of the canopy to the vehicle's cabin.

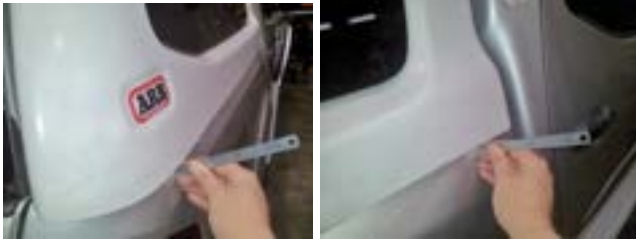
6.8) Measure the trim edges of the canopy at the rear sides and at the front both sides, to the vehicle's tub.

This measurement should be even on both sides of the canopy.

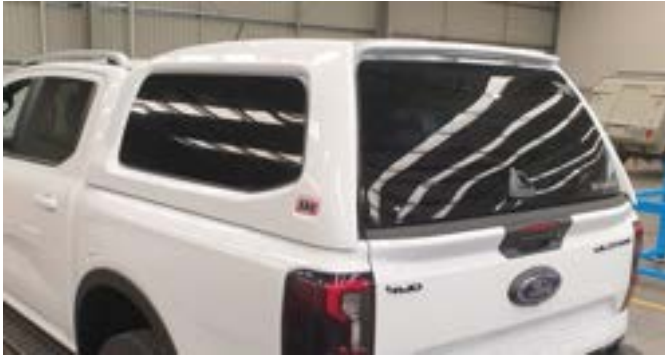
6.9) Stand back and walk around the canopy and check uniform balanced fit to the tub and cabin.

- The canopy is central on the Ute body.
- Alignment between cab and canopy is even both sides
- The rear door seals against the tailgate door sealing stop evenly both sides without excessive force on glass to close.
- The gap is even between the door and shell on both sides.

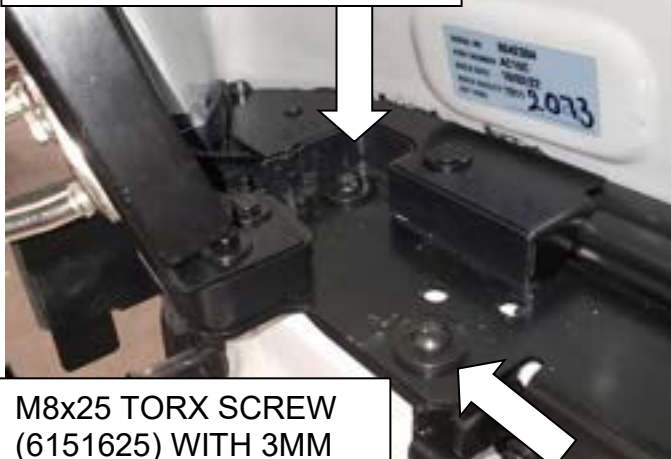
M8x35 TORX
SCREW(6151881) WITH
3MM THICK WASHER

M8x25 TORX SCREW
(6151625) WITH 3MM
THICK WASHER

6.11) In rear corner assemble one M8x35mm screw (6151881) with one M8x25.4x3mm thick washer (4581303) and fasten it down through the back corner of the canopy's base rail.

Tighten to 20 Nm on both sides.

On the inner edge of the rear corner of the base rail, assemble one M8x25mm torx head screw (6151625) with one, M8 3mm thick washer (4581303) to rear tub mount bracket (668PD157R/L) – do not add bottom washer of nyloc nut yet.

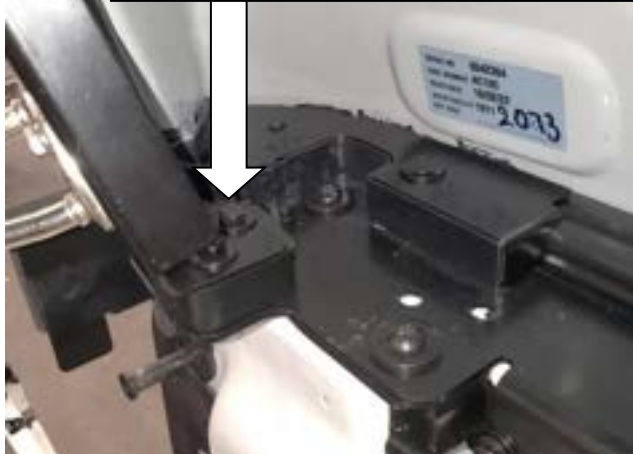
REMOVE M6 NYLOC NUT
UNDERNEATH HERE TO INSTALL
TAILGATE SEAL BRACKET

6.12) Locate outer most M6 nut and bolt assembly on door frame lower bracket and remove bottom M6 nyloc nut and washer. Discard the nut.
Do this on both sides.

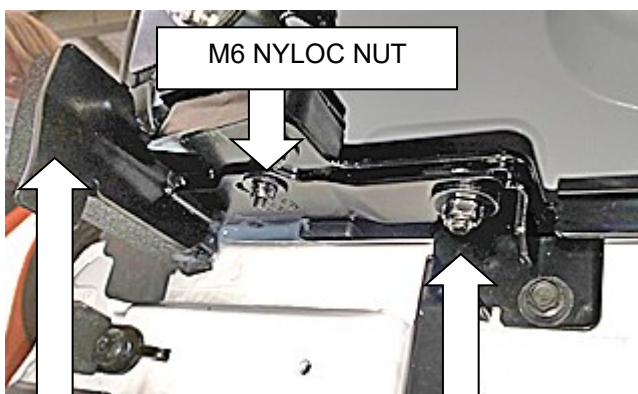
M6 NYLOC NUT

668PD159L BRACKET

M8 NYLOC NUT
M8 WASHER 3MM
THICK

6.13) Take rear tub tailgate corner sealing bracket (668PD159R/L) (RH shown) and place it under the canopy's base rail and align the bracket's slots with the M6 and M8 bolts.

Loosely assemble a new M6 nyloc nut (6151223) with the retained washer and an M8 nyloc nut (6151212) and M8x25.4x3mm thick washer (4581303) to the underside of the (668PD159R) bracket and allow bracket to move freely back and forward.

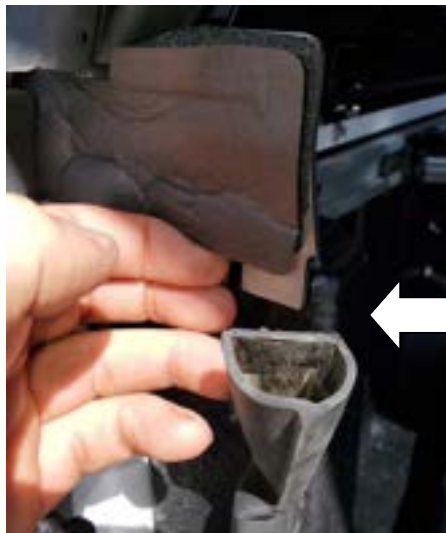
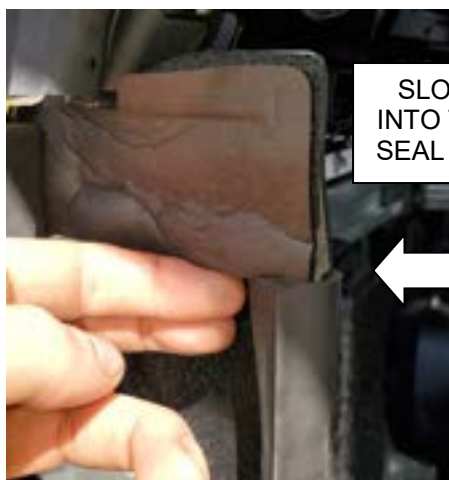
SLOT TAB INTO TOP OF SEAL CAVITY

6.16) **If a Wildtrak bed liner is installed on the tub, locate the tailgate rubber bulb seal (where it was cut in fitting instructions 37801115) and slide it up on lower tabs of the rear corner sealing brackets (668PD159R/L) to meet up to the foam sealing pads on the brackets.**

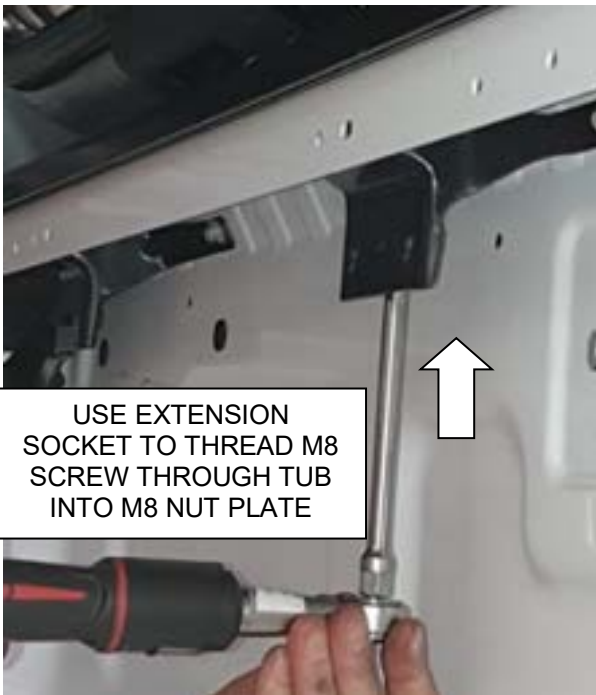
(6151681) M8 x 35 HEX BOLT
(4581085) M8 FLAT WASHER

USE EXTENSION SOCKET TO THREAD M8 SCREW THROUGH TUB INTO M8 NUT PLATE

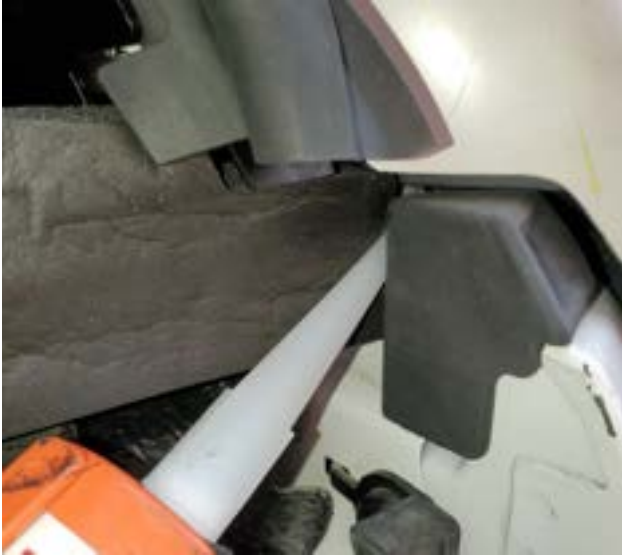
Note: Silicon is to run behind rubber corner block seal (668PE057R/L).

Clean up excess and make silicon neat.

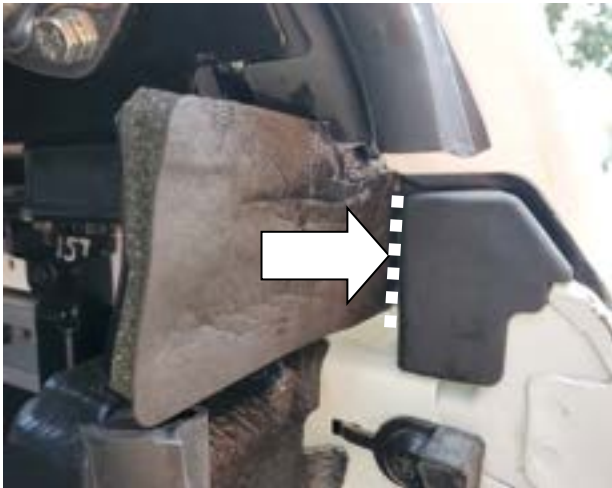
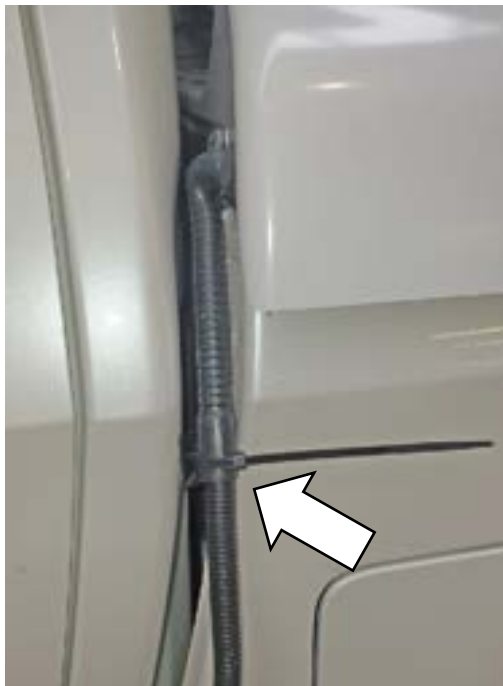
6.24) Cable tie the (6821293) cable tie base to the canopy loom at the front LH outer corner of the canopy, in the location shown (on the base of the rubber grommet) tight enough to not allow it to fall down the loom and in the orientation shown.

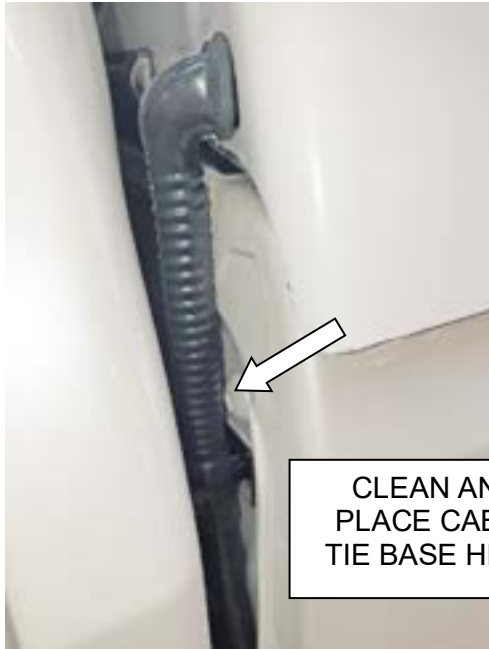
6.25) Reaching between the tub and cabin on left hand side with an alcohol wipe, clean an area on the front of the tub level to where the cable tie base will be fitted.

6.26) Peel the protection film off the cable tie base (6821293) and drop the canopy loom down between the cabin and tub on the LH side.

6.27) Reaching in between the cabin and the tub, press the cable tie base firmly onto the front of the tub and ensure it has adhered firmly.

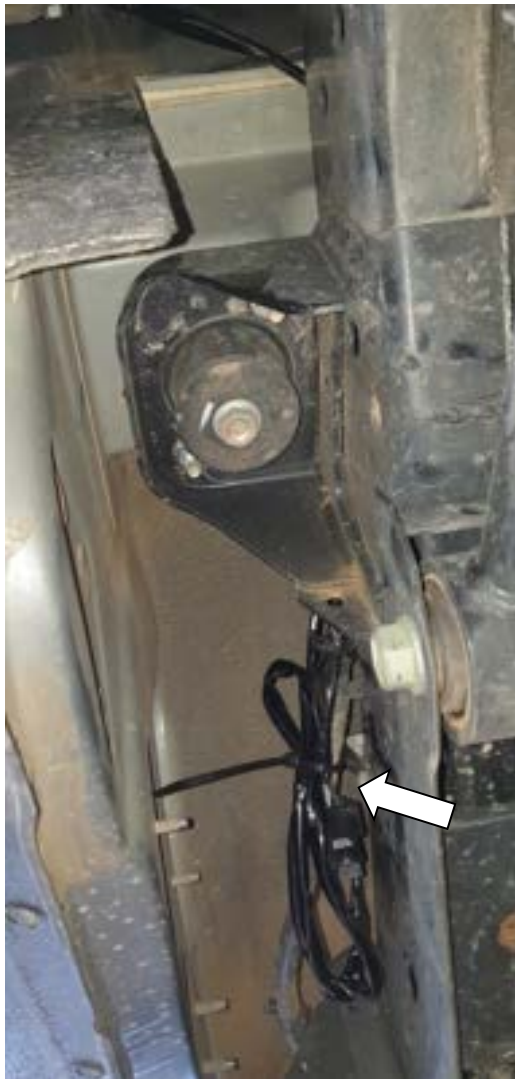
6.28) Connect the canopy wiring connector to the end connector of the canopy wiring harness (668PJ031) fitted to the vehicle, in the plenum above the LH chassis rail forwards of the LH rear cabin body mount.

6.29) Cable tie the remaining harness up in the cavity and tie it off to the vehicle's main wiring loom.

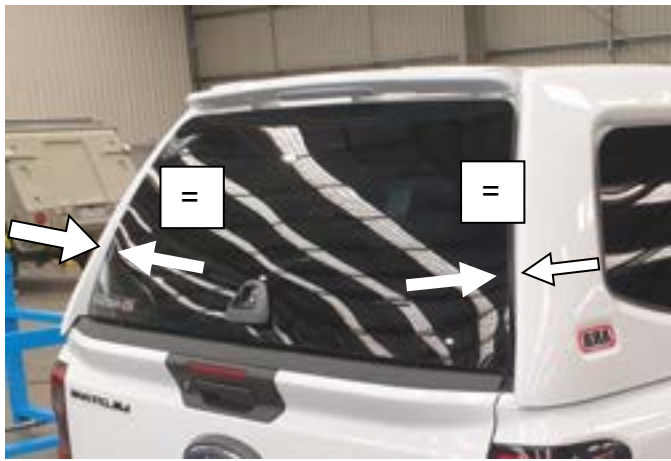
Press the button underneath to check the door releases on the actuator and the pressure is not too high to stop it unlatching.

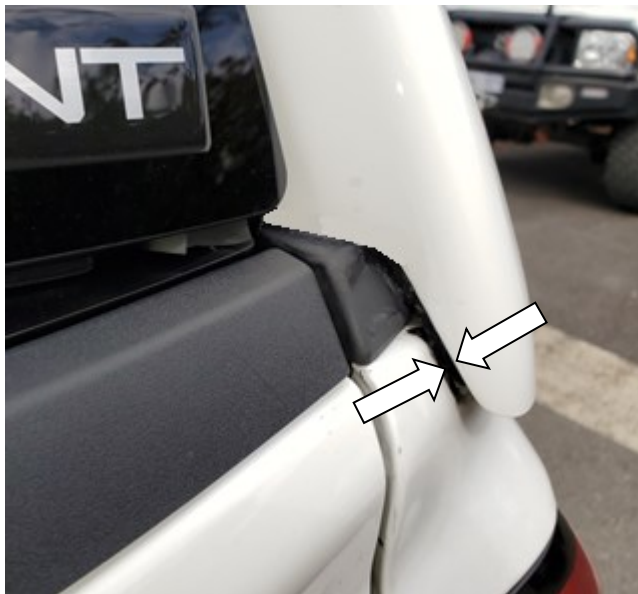
6.35) Check the gap of the canopy shell's trim edge corners to the tub. It should be even on both sides of the canopy.

!! IMPORTANT !! The gap must not be below 5mm. Move the canopy rearward if required

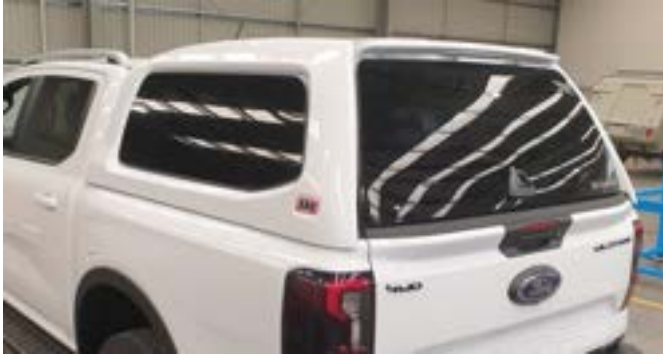
6.37) Water test the canopy around all windows and joins to the tub with high pressure hose and seal or report any leaks found.

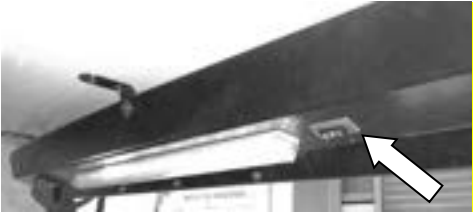
<p>7.1) Move the interior light switch to the position II where it will turn off when the door is closed and turn on when the door is opened.</p>

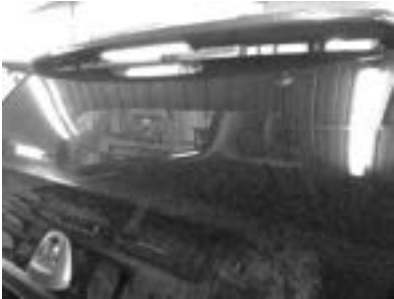
<p>7.2) Depress the vehicle's brake pedal and have a second person check that the brake light in the spoiler works.</p>

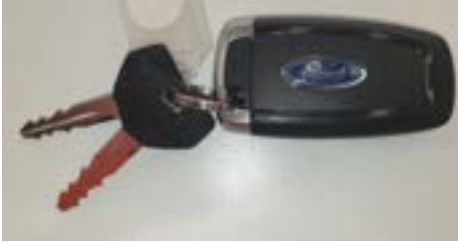
<p>7.3) Remove the key from the rear door handle and combine this with the key taped inside the canopy. The 2 keys should then be added to the customer's key ring. <u>!! IMPORTANT !! Check BOTH keys work manually in the rear door lock.</u></p>
