DUAL CAB CENTRAL LOCKING CANOPY

Ascent Canopy USA ONLY AC24CXX – Ford Ranger Dual Cab 2024
(2024 Vehicle Production Onwards. Fits XL,XLT, Lariat, Raptor)

FITTING KIT: TAILGATE AND HEAD BOARD KIT 6178556. TUB MOUNT KIT 6178688

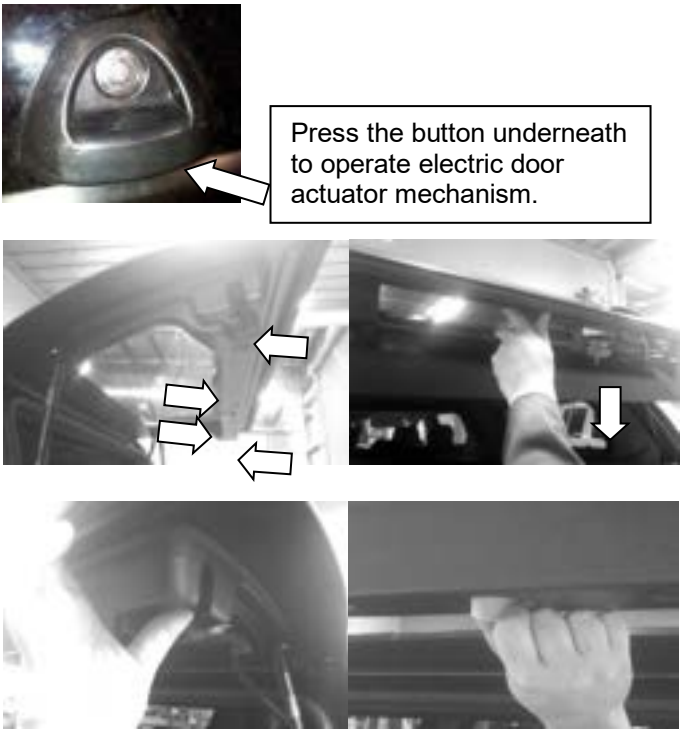
<p>7.4) Operate the door push button switch to open and close the door. If one side opens before the other, the lock mechanism can be adjusted so that both sides of the door open simultaneously if the following is done:</p> <ul style="list-style-type: none"> • Open the door. Remove the 4 scriveners retaining the lower section of the door interior cover using a flat blade screw driver under the head. Slightly pry the door cover down away from the glass. • Close both of the latch pawls on the sides of the door glass with your fingers. Slowly turn the interior door release handle and listen to hear if both latches click open at the same time with the door cover pushed back up to the glass whilst ensuring the latch rods are located into the foam blocks on the door cover.

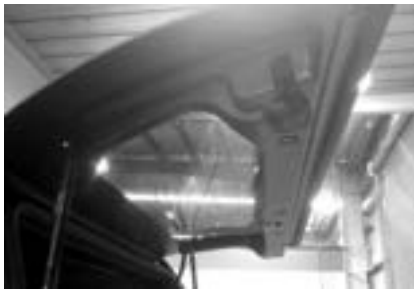
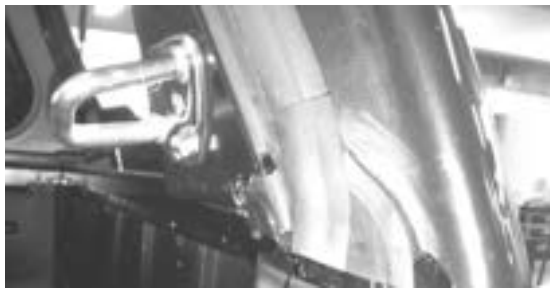
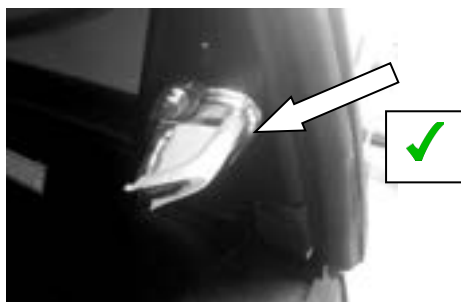
- If the latches do not operate simultaneously, locate the black plastic clips on each end of the pull rods to the latches, unclip a pull rod, lengthen or shorten it by winding it in/out and re-clip in. Close the latches with your fingers again and test operation via the interior rear door handle to operate simultaneously.
- Once satisfied, refit the door cover lower portion with the scrivenets, but ensure to guide the pull rods into slits in the foam blocks on the door cover at both ends.

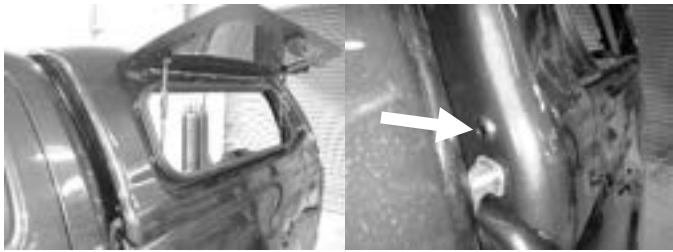
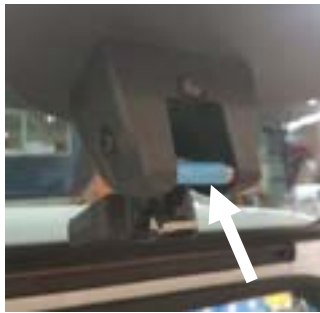
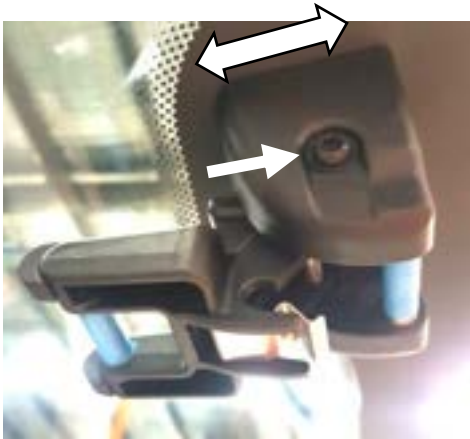
- Place one thickness of masking tape around the striker bar where the latches contact. Open and close the door. If the tape shown signs of wear through on the top side or underneath of the striker bar, it is necessary to adjust the striker away from the side on which the wear is shown. **The aim is only to have wear on the outward face of the striker bar.**
- Undo the M6 screws slightly on the strikers and adjust their position slightly. **Re-torque screws to 9Nm.**
- Test the door again and adjust via the above methods until satisfied.
